## Structural Assessment Report

228 SW 83 WAY BLDG. 4  
PEMBROKE PINES, FL 33025

**RE:** Structural Assessment Report with respect to the property located at:  
Final Report  
228 SW 83 Way  
Pembroke Pines, FL 33025

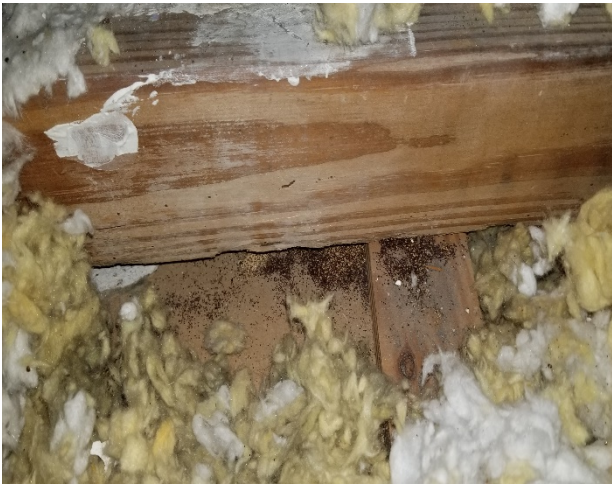
**Photograph 9: Unit 201. Termite infestation**

8. The entire building must be treated for termites prior to the repairs and inspected again for termites following the repairs. If termites persist, the building must be treated again.

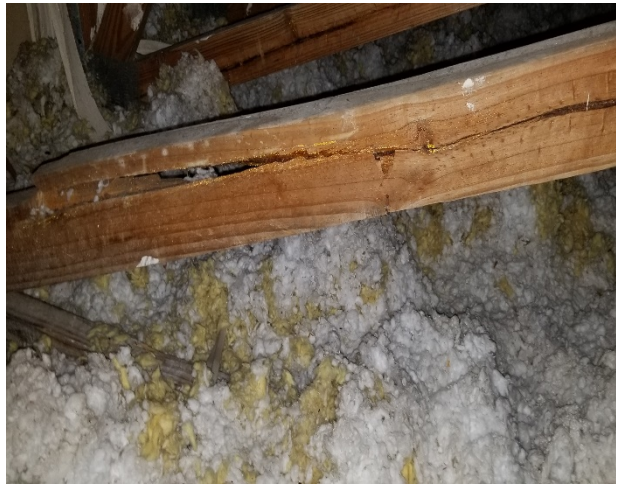
**Photograph 10: Unit 202. Isolated damage to roof truss**

3. The floor flat trusses must be exposed in all bathrooms and air handler closets. All moisture damaged framing must be repaired.
4. The insulation within the attic space must be vacuumed and all bottom chords of roof trusses must be inspected and repaired if found structurally damaged.

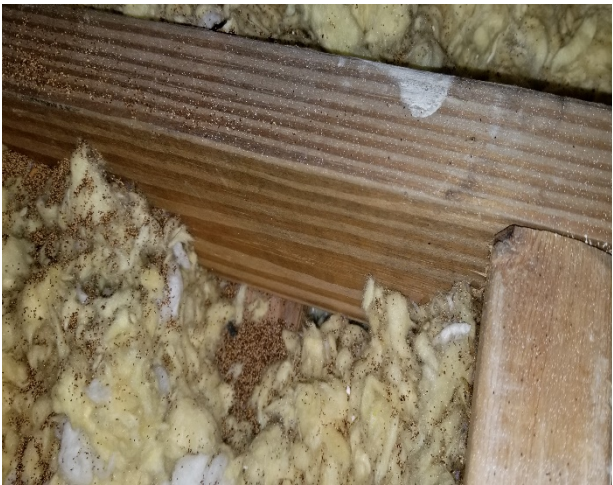
**Photograph 11: Unit 207. Termite infestation**

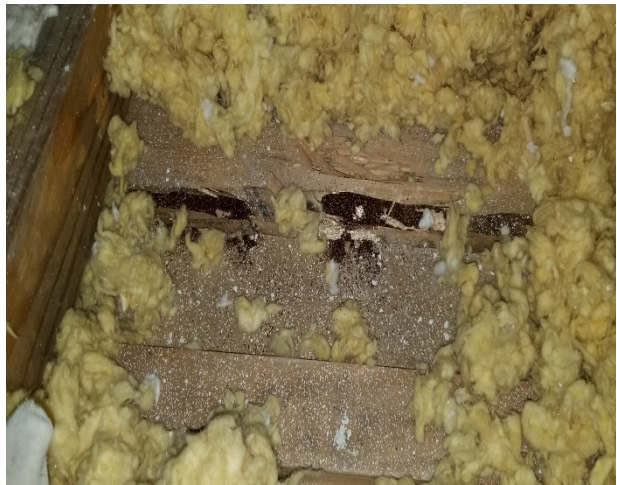
**Photograph 12: Unit 208. Termite infestation**

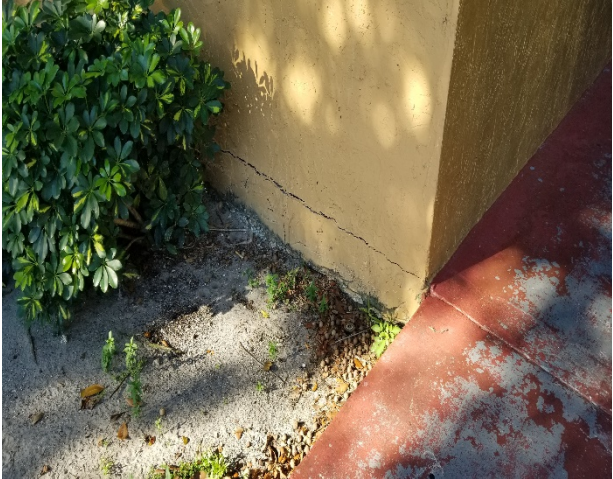
***Photograph 13: Soild washout and exterior wall crack***

7. All trees and shrubs along the perimeter of the building must be removed along with its roots. The finish grade must be restored and compacted sloping away from the exterior wall in accordance with Florida building Code Section 1804.4.

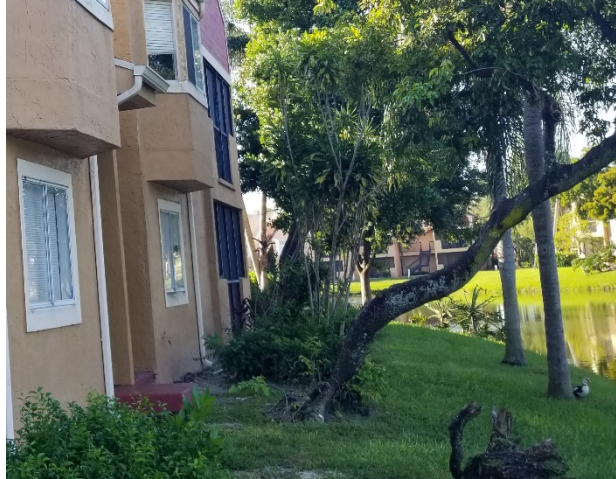
***Photograph 14: Tree roots growing against the foundation***
