## Structural Assessment Report

Building 6

356 SW 83 Way

**RE:** Structural Assessment Report with respect to the property located at:  
Final Report  
Building 6  
356 SW 83 Way  
Pembroke Pines FL 33025

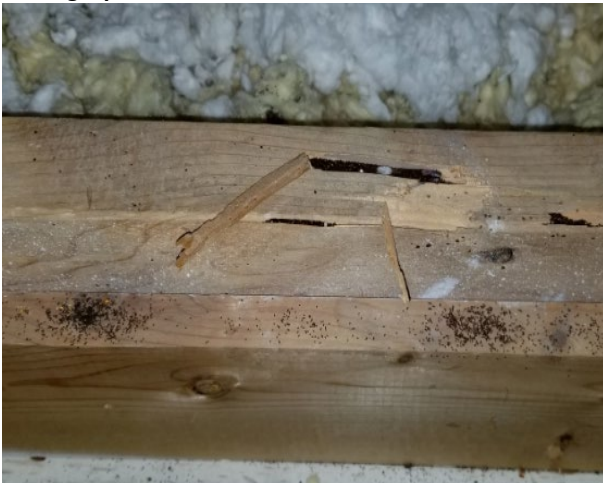
**Photograph 5: Unit 202. Termite Infestation**

8. The entire building must be treated for termites prior to the repairs and inspected again for termites following the repairs. If termites persist, the building must be treated again.

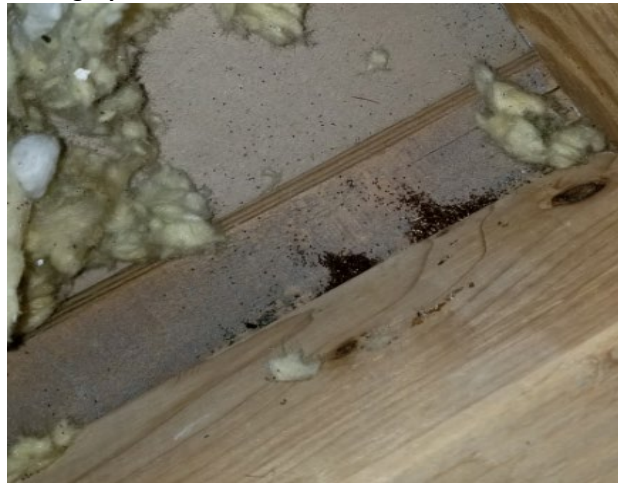
**Photograph 6: Termite Infestation**

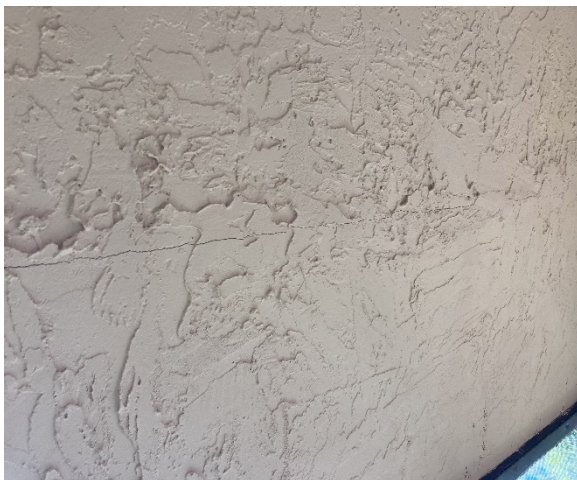
**Photograph 11: Cracks on balcony ceiling Unit 104**

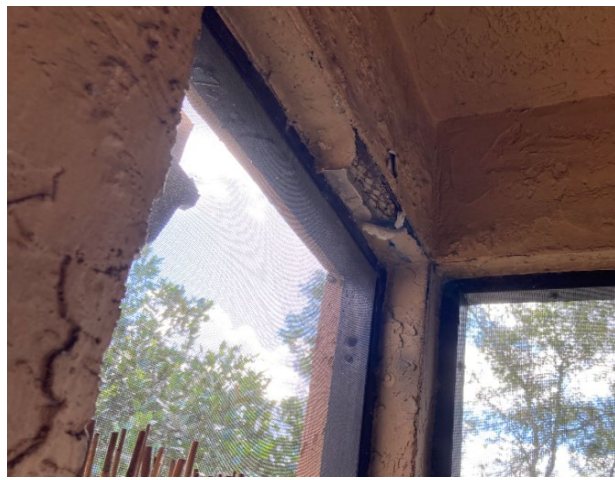
**Photograph 12: Exposed wire lath on Unit 204 balcony**

1. Stucco along the perimeter walls must be stripped to the wood sheathing along the entire building.
2. The areas showing deteriorated sheathing and/or wood studs must be replaced. The remaining visibly sound structural framing must be evaluated by a special inspector.

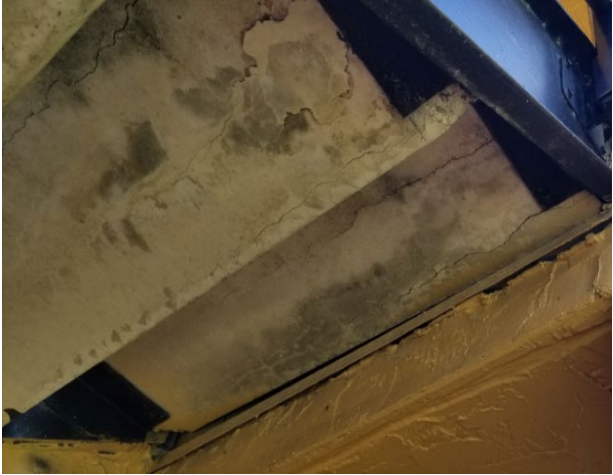
**Photograph 13: Exterior staircase. Spalling and cracks**

5. All household items stored in the attic space are a fire hazard and must be removed.
6. All staircases must be cleaned from corrosion, welded as needed, and painted. All cracked concrete steps must be replaced.

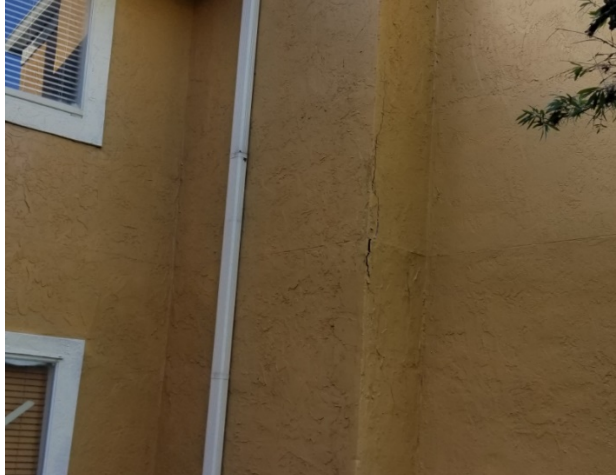
**Photograph 14: Cracks on the exterior walls**
