## Structural Assessment Report

Building 7

420 SW 83rd Way

**RE:** Structural Assessment Report with respect to the property located at:  
420 SW 83rd Way  
Pembroke Pines FL 33025

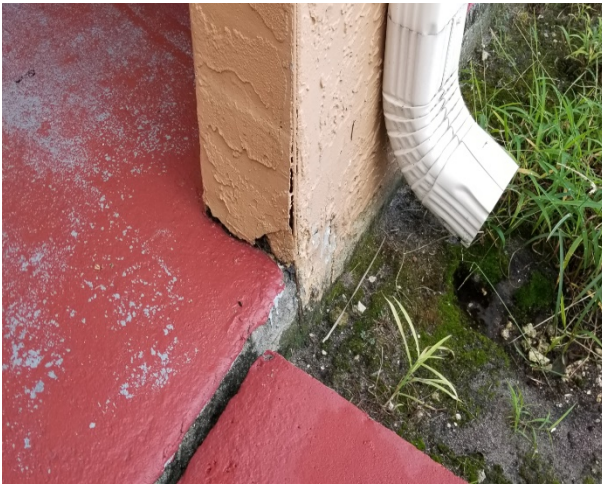
**Photograph 9: Corner crack on exterior wall near downspout**

1. Stucco along the perimeter walls must be stripped to the wood sheathing along the entire building.
2. The areas showing deteriorated sheathing and/or wood studs must be replaced. The remaining visibly sound structural framing must be evaluated by a special inspector.

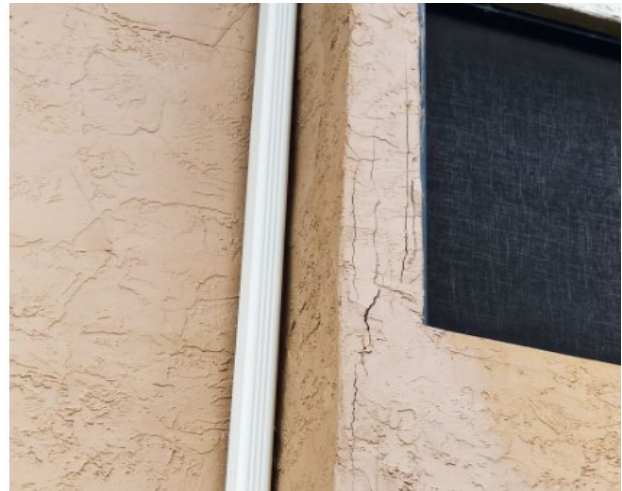
**Photograph 10: Exterior wall cracking**

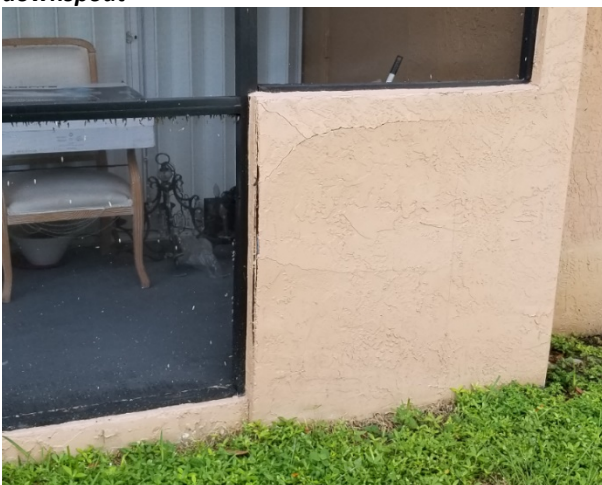
**Photograph 11: Exterior wall cracking**

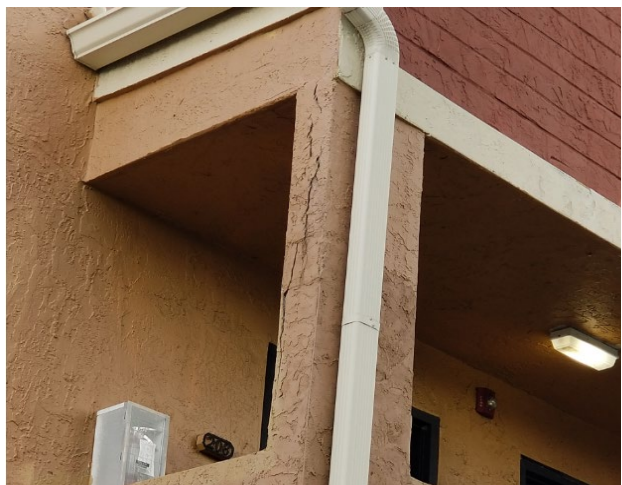
**Photograph 12: Exterior wall cracking**

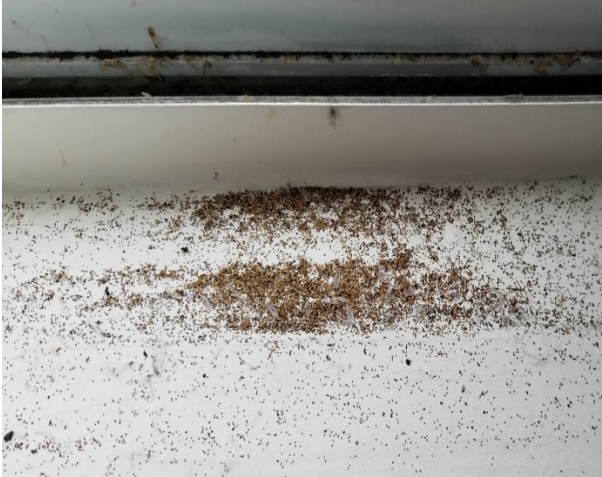
**Photograph 13: Unit 208. Termites infestation**

8. The entire building must be treated for termites prior to the repairs and inspected again for termites following the repairs. If termites persist, the building must be treated again.

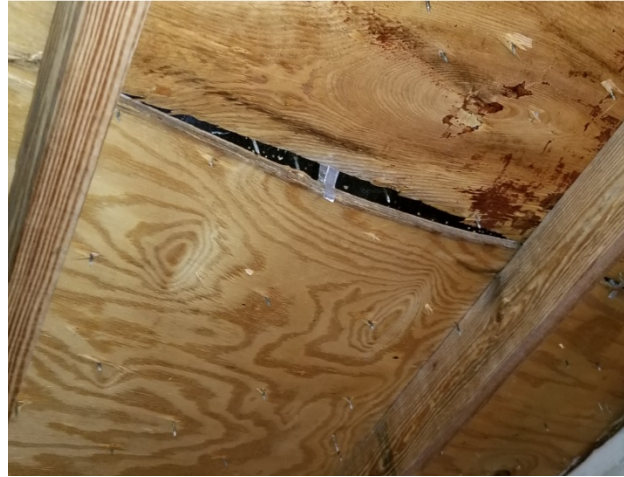
**Photograph 14: Unit 208. Opening within the attic sheathing**
