Structural Assessment Report

8375 SW 5th ST., BLDG 10
PEMBROKE PINES, FL 33025

Friday, October 8, 2021

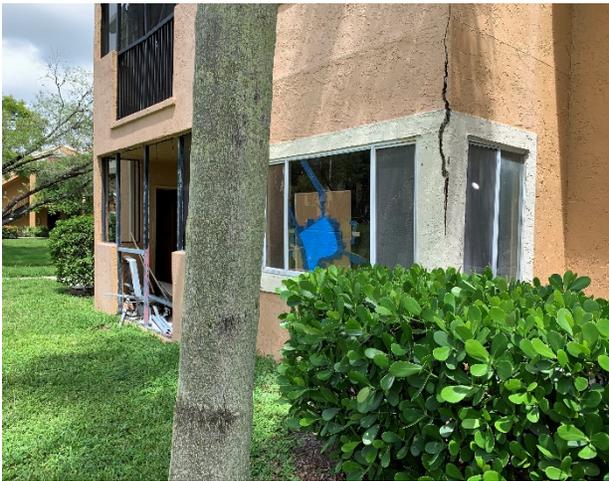
Photograph 1: Building elevation Blue Tarp required

9. Install blue tarp over units 101 and 201 to protect the building from water intrusion. The tarp must be hanging down from the roof line and covering the opening in the wall.

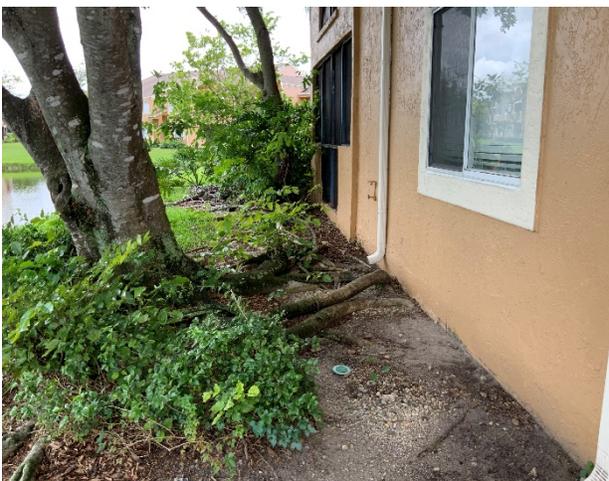
Photograph 9: Unit 106. Vegetation overgrowth into the foundation.

7. All trees and shrubs along the perimeter of the building must be removed along with its roots. The finish grade must be restored and compacted sloping away from the exterior wall in accordance with Florida building Code Section 1804.4.

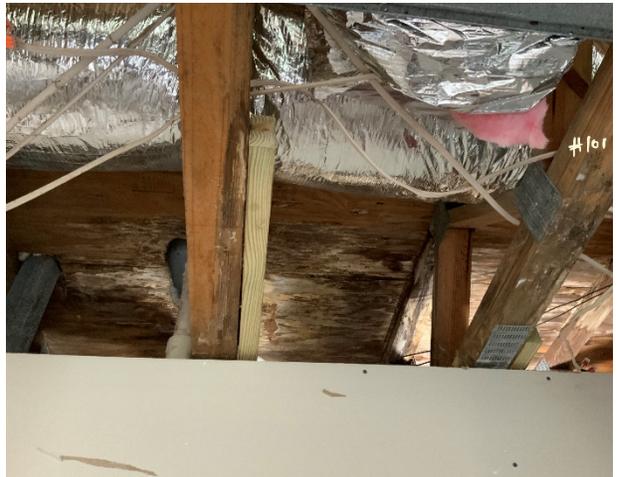
Residents of several first-floor units reported multiple previous plumbing or a/c leaks underneath bathrooms and air handler closets of the second-floor units. In addition, at the time of this assessment, unit 101 wood floor framing was exposed throughout the unit. The wood framing in the bathrooms was noted to be moisture deteriorated and structurally compromised.

Photograph 14: Unit 101. Moisture damaged floor framing

Therefore, the ceiling drywall in all remaining units in the bathrooms and a/c closets on the first floor must be exposed and all moisture damaged wood framing, including flat wood trussed and plywood, must be repaired.

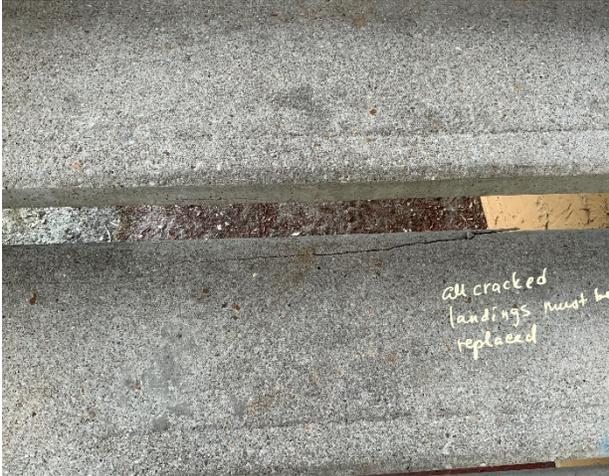
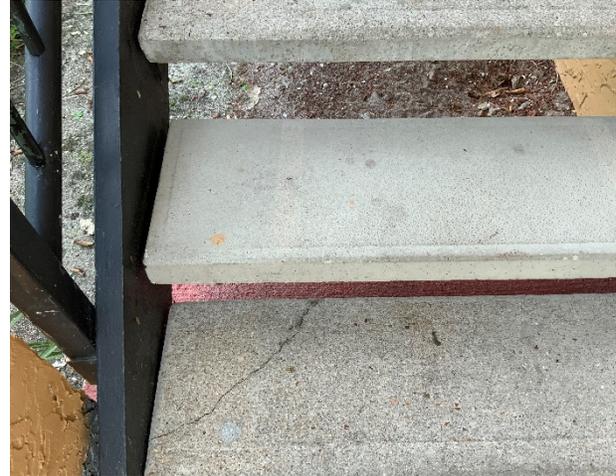
Photograph 17: Common staircase cracked concrete step

Photograph 18: Common staircase cracked concrete step

5. All household items stored in the attic space are a fire hazard and must be removed.
6. All staircases must be cleaned from corrosion, welded as needed, and painted. All cracks concrete steps must be replaced.
