## Structural Assessment Report

8407 SW 5 STREET BUILDING 11  
PEMBROKE PINES FL 33025

**RE:** Structural Assessment Report with respect to the property located at:  
Final Report  
8407 SW 5 STREET BUILDING 11  
PEMBROKE PINES FL 33025

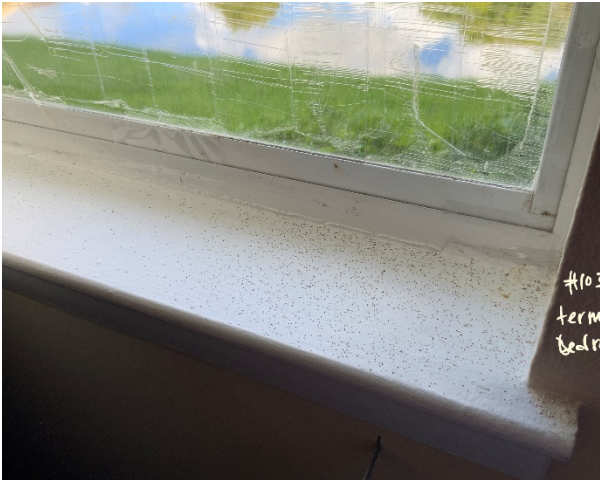
**Photograph 3: Unit 103. Termites droppings**

8. The entire building must be treated for termites prior to the repairs and inspected again for termites following the repairs. If termites persisted, the building must be treated again.

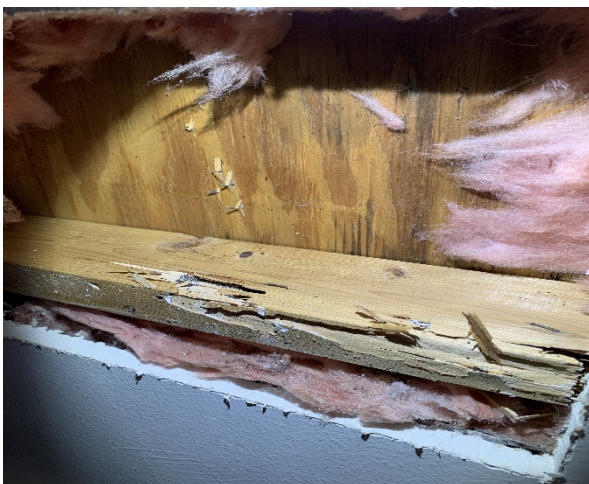
**Photograph 11: Unit 205. Termites Damage**

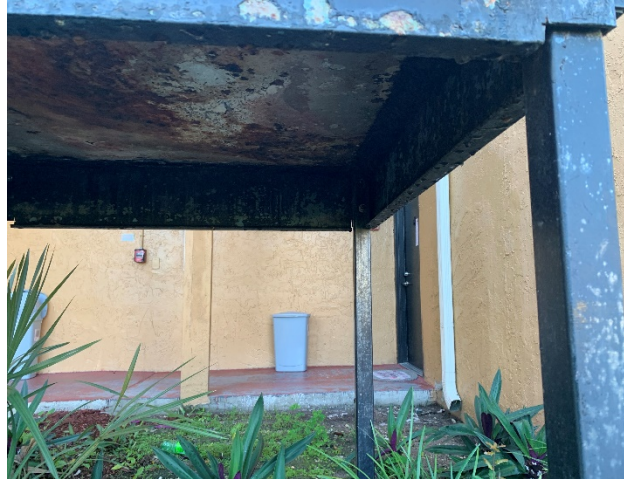
**Photograph 14: Common areas staircase landing and columns**

5. All household items stored in the attic space are a fire hazard and must be removed.
6. All staircases must be cleaned from corrosion, welded as needed, and painted. All cracks concrete steps must be replaced.
