## Structural Assessment Report

Building 12

8439 SW 5 Street

**RE:** Structural Assessment Report with respect to the property located at:  
Final Report  
Building 12  
8439 SW 5 Street  
Pembroke Pines FL 33025

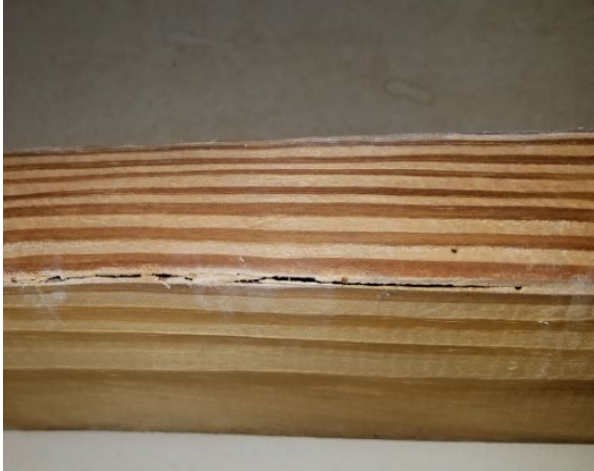
**Photograph 7: Unit 205 cracked wood joists within attic**

4. The floor flat trusses must be exposed in all bathrooms and air handler closets. All moisture damaged framing must be repaired.
5. The insulation within the attic space must be vacuumed and all bottom chords of roof trusses must be inspected and repaired if found structurally damaged.

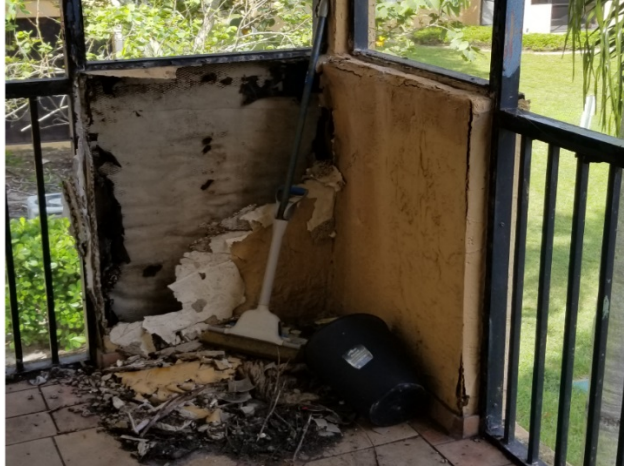
**Photograph 8: Unit 208 Balcony**

Balcony in Unit 208 was found to have a deteriorated structural wooden column compromising the safety of the residents. Temporarily shoring system must be installed immediately in accordance with plans and specifications.

1. Temporarily shoring system in accordance with the plans and specifications must be installed immediately to support the balcony in Unit 208.
2. Stucco along the perimeter walls must be stripped to the wood sheathing along the entire building.

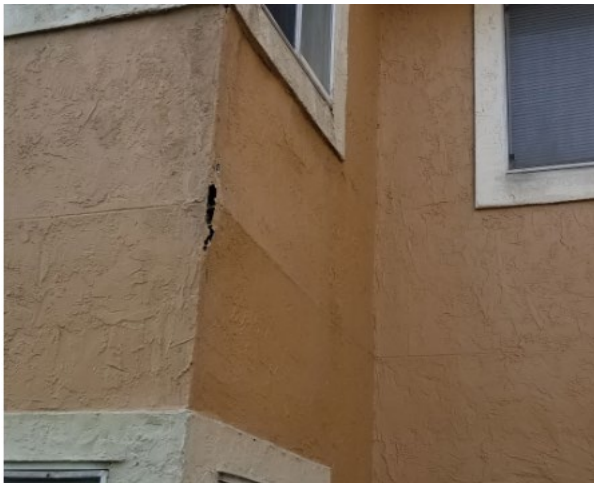
**Photograph 11: Opening in the exterior wall**

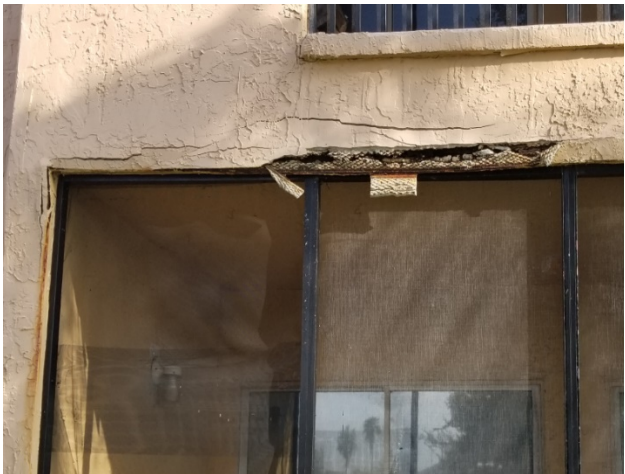
**Photograph 12: Exterior wall cracking and exposed wire lath**

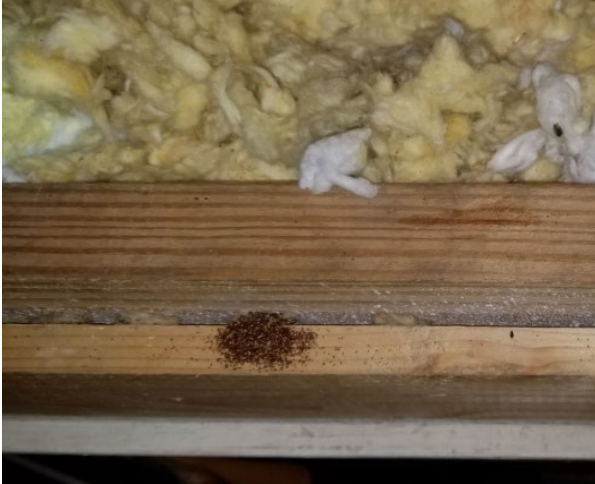
**Photograph 13: Unit 202. Termites infestation**

9. The entire building must be treated for termites prior to the repairs and inspected again for termites following the repairs. If termites persist, the building must be treated again.

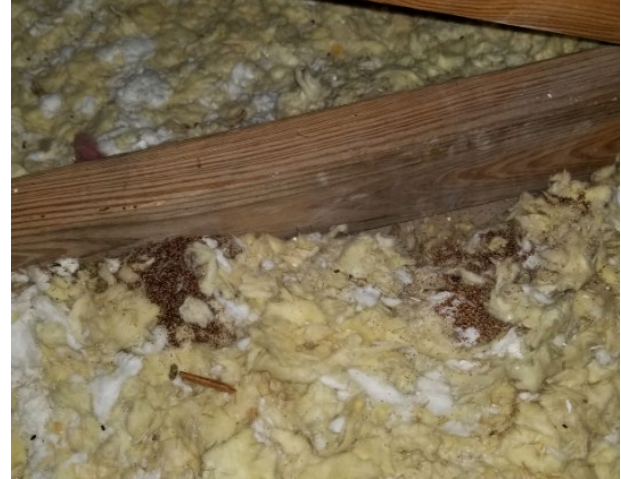
**Photograph 14: Unit 208. Termites infestation**
