## Structural Assessment Report

8420 SW 3 CT., BLDG 15  
PEMBROKE PINES, FL 33025

**RE:** Structural Assessment Report with respect to the property located at:  
Final Report  
8420 SW 3 Ct  
Pembroke Pines, FL 33025

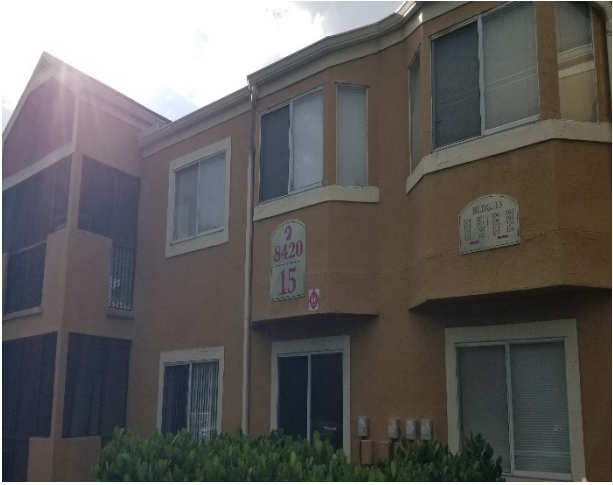
**Photograph 1: Building elevation**

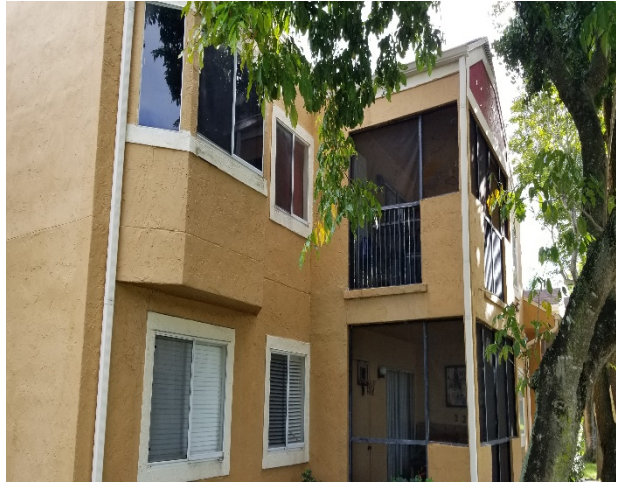
**Photograph 2: Building elevation**

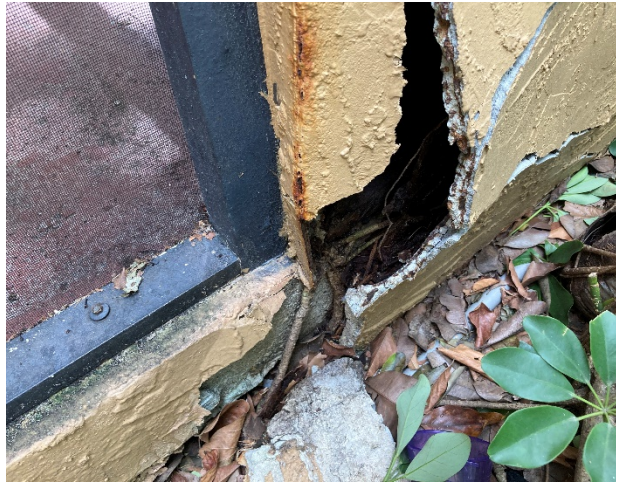
**Photograph 4: Unit 105. Opening in the exterior wall**

1. Stucco along the perimeter walls must be stripped to the wood sheathing along the entire building.
2. The areas showing deteriorated sheathing and/or wood studs must be replaced. The remaining visibly sound structural framing must be evaluated by a special inspector.

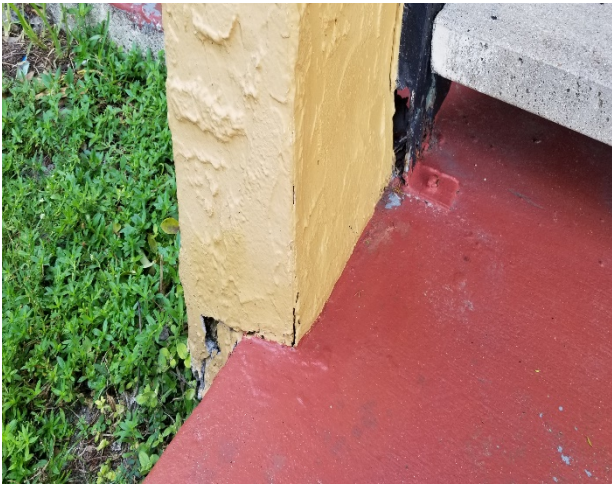
**Photograph 9: Opening in the exterior wall**

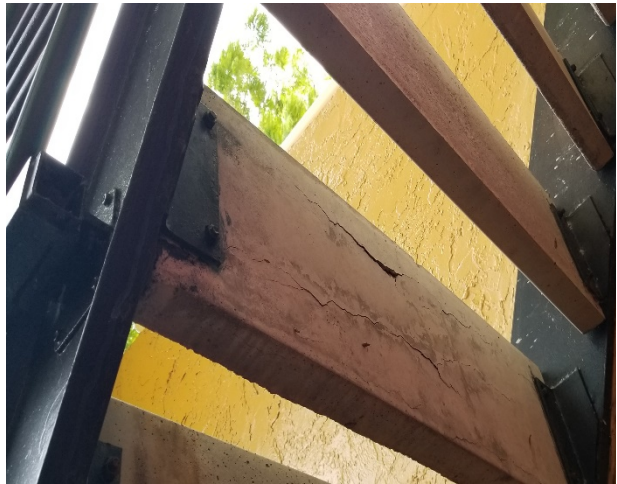
**Photograph 10: Concrete steps cracking**

5. All household items stored in the attic space are a fire hazard and must be removed.
6. All staircases must be cleaned from corrosion, welded as needed, and painted. All cracked concrete steps must be replaced.
