## Structural Assessment Report

321 SW 84 AVE., BLDG 17  
PEMBROKE PINES, FL 33025

**RE:** Structural Assessment Report with respect to the property located at:  
Final Report  
321 SW 84 AVE  
Pembroke Pines, FL 33025

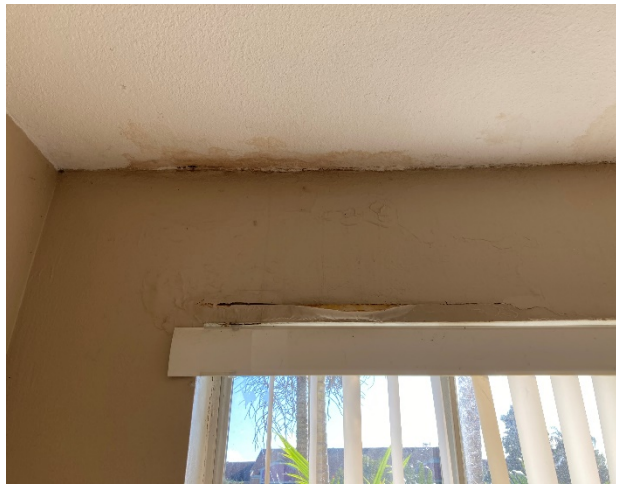
**Photograph 4: Unit 108. Moisture stains and cracks within the interiors**

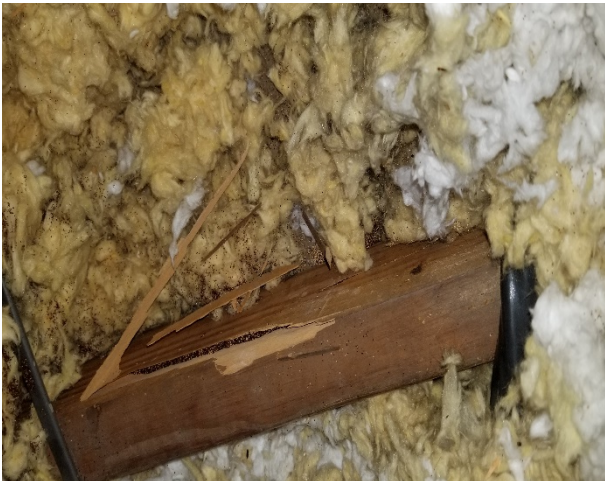
**Photograph 9: Unit 201. Termites infestation and damage to the bottom truss chord**

3. The floor flat trusses must be exposed in all bathrooms and air handler closets. All moisture damaged framing must be repaired.
4. The insulation within the attic space must be vacuumed and all bottom chords of roof trusses must be inspected and repaired if found structurally damaged.

8. The entire building must be treated for termites prior to the repairs and inspected again for termites following the repairs. If termites persist, the building must be treated again.

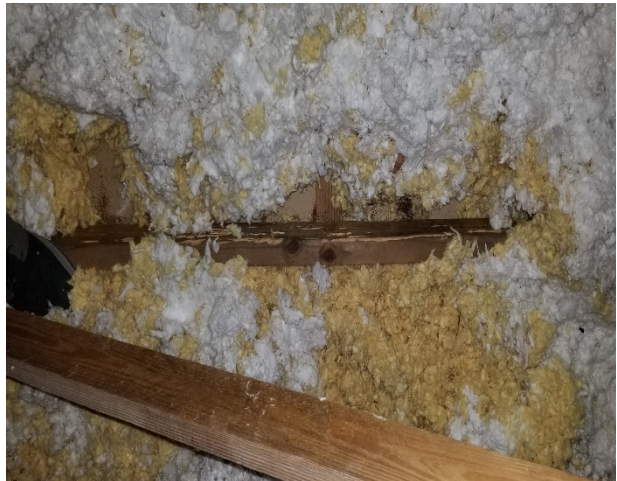
**Photograph 10: Unit 206. Termites infestation and damage to the bottom truss chord**

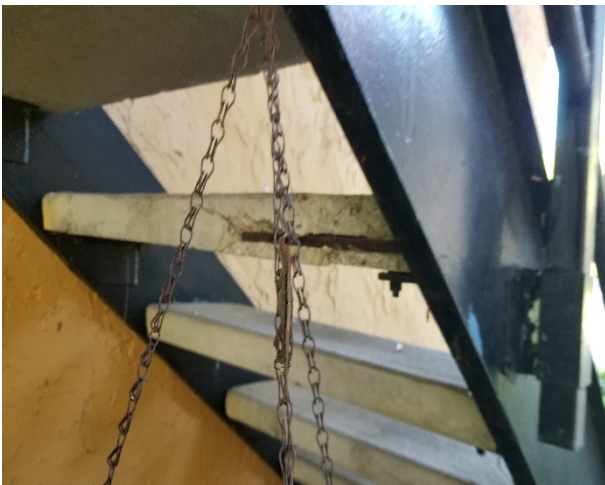
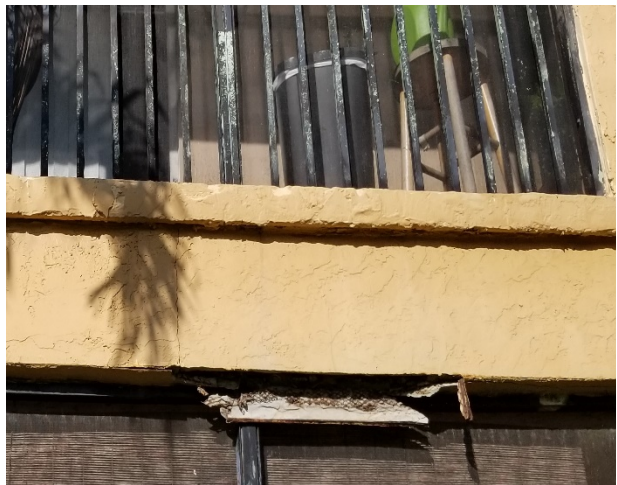
**Photograph 11: Spalling on the concrete step for the common staircase**

5. All household items stored in the attic space are a fire hazard and must be removed.
6. All staircases must be cleaned from corrosion, welded as needed, and painted. All cracked concrete steps must be replaced.

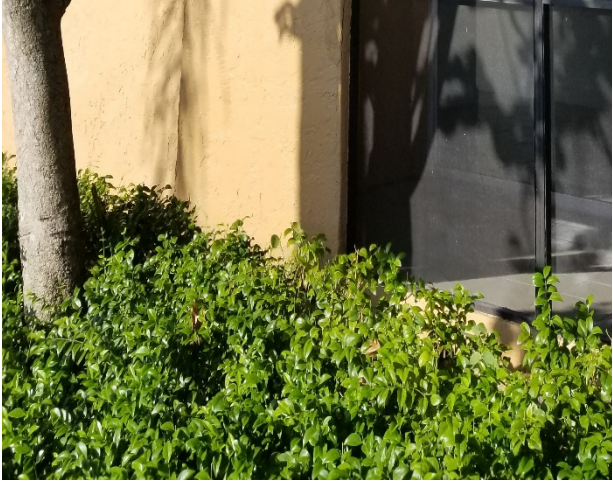
**Photograph 12: Opening in the exterior wall**
