## Structural Assessment Report

241 SW 84 AVE., BLDG 18  
PEMBROKE PINES, FL 33025

**RE:** Structural Assessment Report with respect to the property located at:  
Final Report  
241 SW 84 AVE  
Pembroke Pines, FL 33025

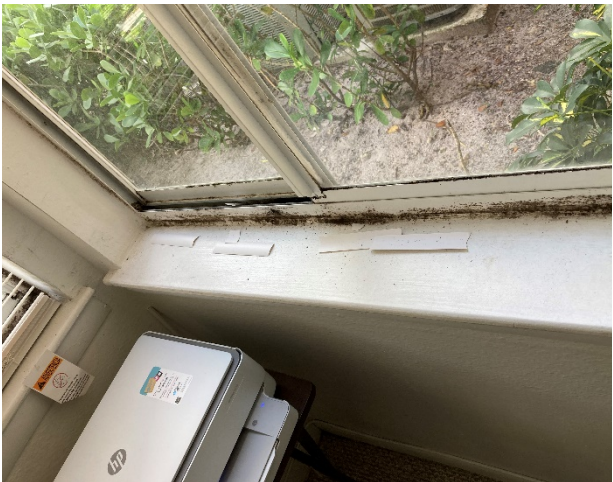
**Photograph 3: Unit 104. Termites infestation and moisture damage**

8. The entire building must be treated for termites prior to the repairs and inspected again for termites following the repairs. If termites persist, the building must be treated again.

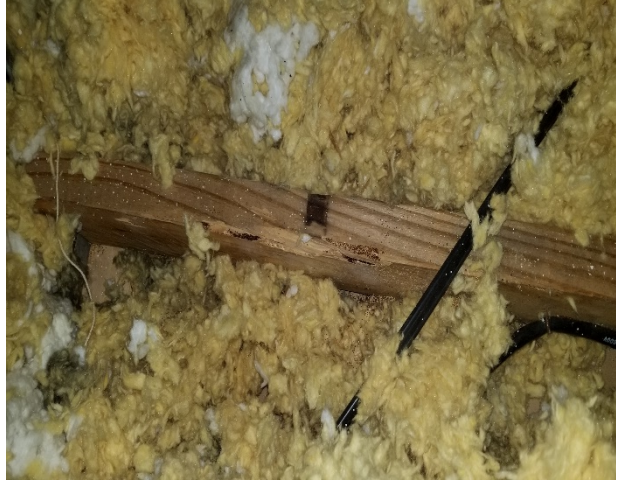
**Photograph 7: Unit 205. Sagging sheathing within the attic**

3. The floor flat trusses must be exposed in all bathrooms and air handler closets. All moisture damaged framing must be repaired.
4. The insulation within the attic space must be vacuumed and all bottom chords of roof trusses must be inspected and repaired if found structurally damaged.

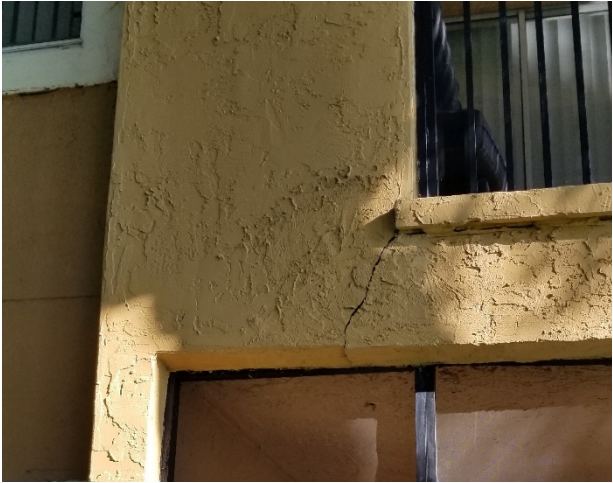
**Photograph 8: Unit 207. Termites infestation**

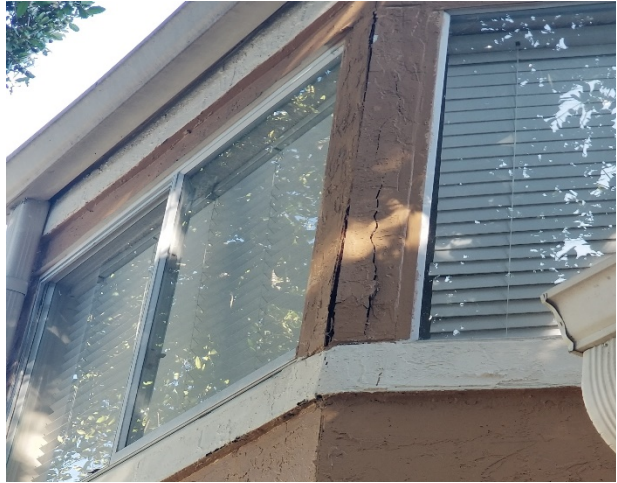
**Photograph 9: Exterior wall crack**

1. Stucco along the perimeter walls must be stripped to the wood sheathing along the entire building.
2. The areas showing deteriorated sheathing and/or wood studs must be replaced. The remaining visibly sound structural framing must be evaluated by a special inspector.

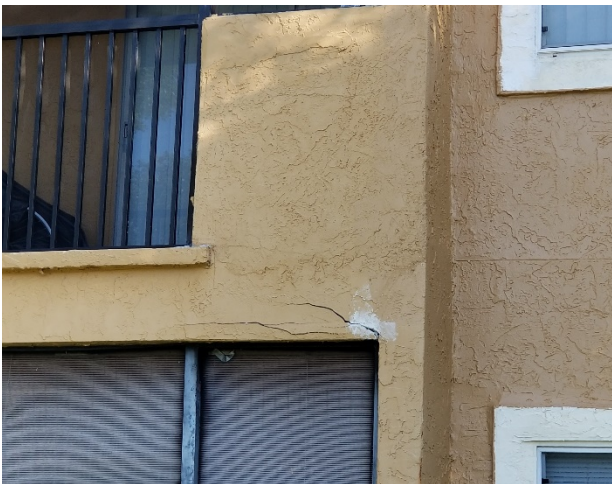
**Photograph 10: Opening in the exterior wall**

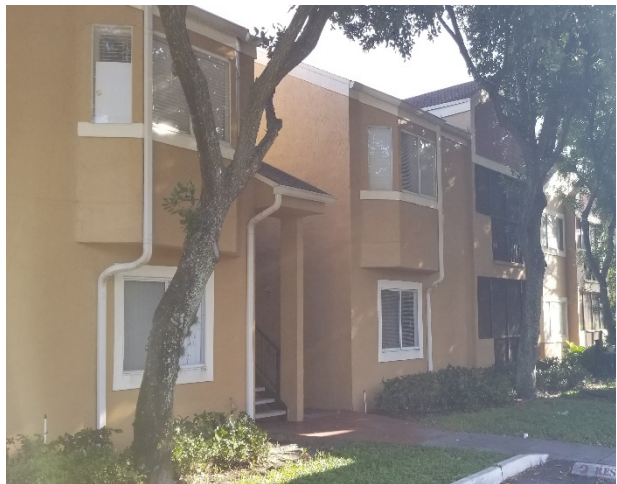
**Photograph 11: Exterior wall crack**
