## Structural Assessment Report

161 SW 84 AVE., BLDG 19  
PEMBROKE PINES, FL 33025

**RE:** Structural Assessment Report with respect to the property located at:  
Final Report  
161 SW 84 AVE  
Pembroke Pines, FL 33025

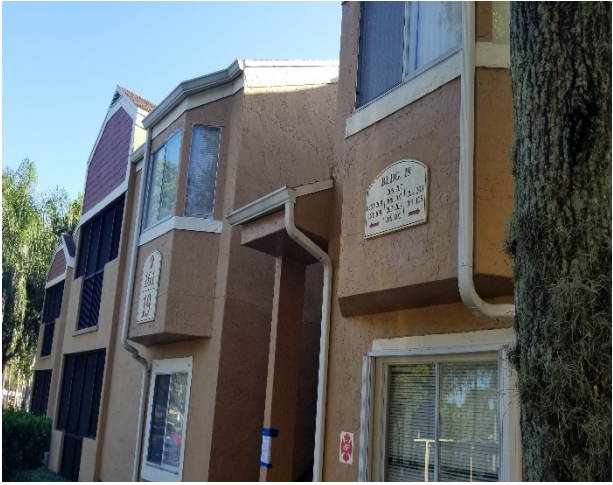
**Photograph 1: Building elevation**

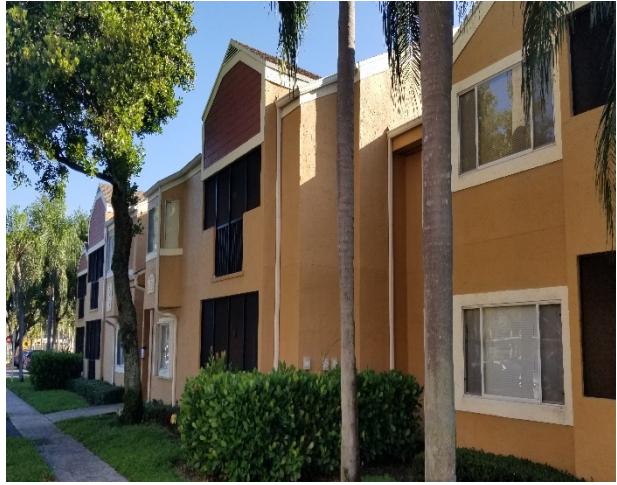
**Photograph 2: Building elevation**

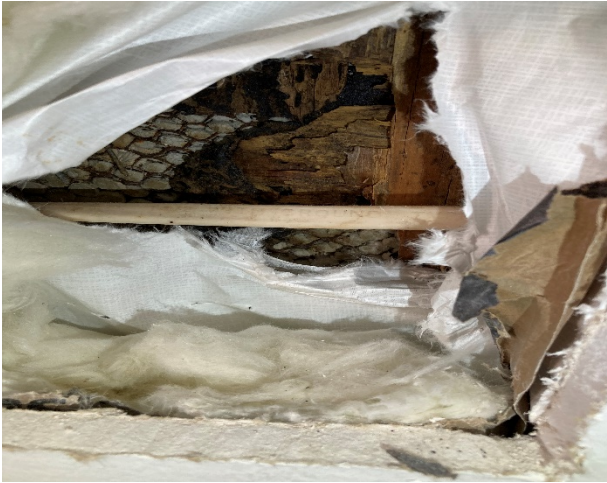
**Photograph 7: Unit 206. Deteriorated sheathing**

1. Stucco along the perimeter walls must be stripped to the wood sheathing along the entire building.
2. The areas showing deteriorated sheathing and/or wood studs must be replaced. The remaining visibly sound structural framing must be evaluated by a special inspector.

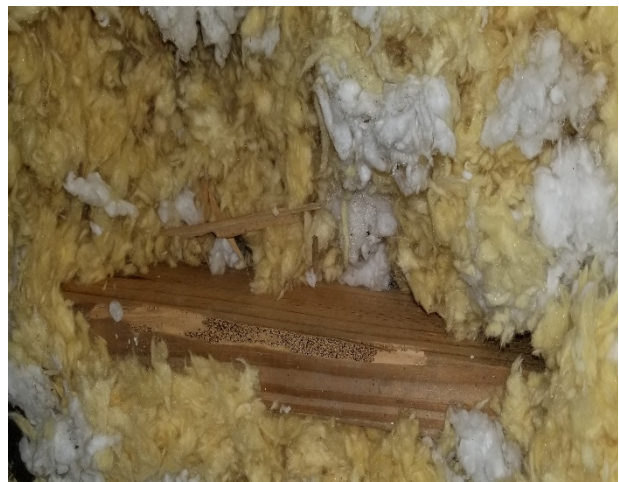
**Photograph 12: Unit 203. Termites infestation**

8. The entire building must be treated for termites prior to the repairs and inspected again for termites following the repairs. If termites persist, the building must be treated again.

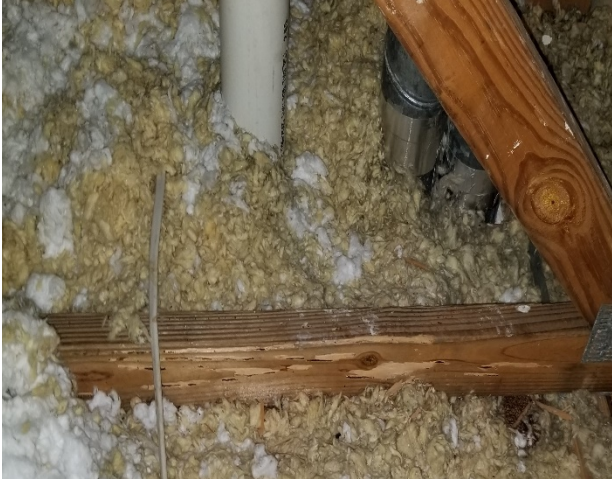
**Photograph 13: Unit 204. Termites infestation and damage to bottom truss chord**

3. The floor flat trusses must be exposed in all bathrooms and air handler closets. All moisture damaged framing must be repaired.
4. The insulation within the attic space must be vacuumed and all bottom chords of roof trusses must be inspected and repaired if found structurally damaged.

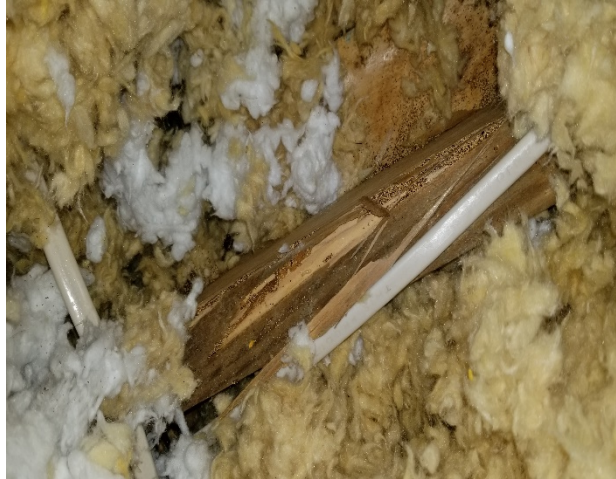
**Photograph 14: Unit 207. Termites infestation and damage to bottom truss chord**

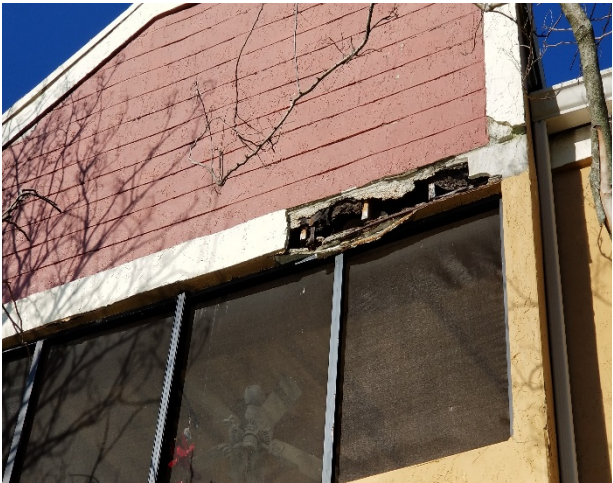
**Photograph 15: Opening in the exterior wall**

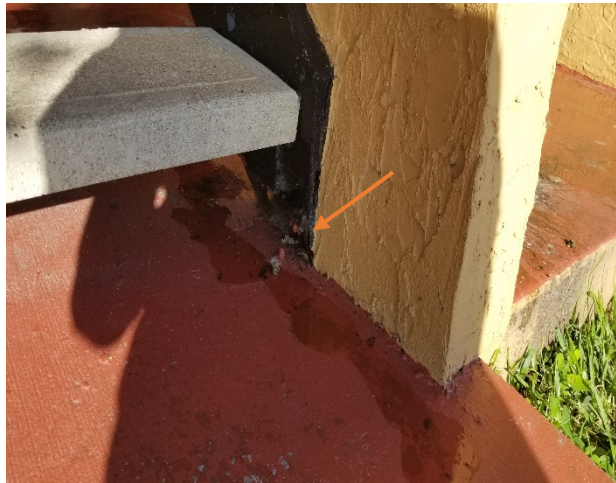
**Photograph 16: Corroded connection for the common metal staircase**

5. All household items stored in the attic space are a fire hazard and must be removed.
6. All staircases must be cleaned from corrosion, welded as needed, and painted. All cracked concrete steps must be replaced.
