Structural Assessment Report

8320 SW 1 St., BLDG 01
PEMBROKE PINES, FL 33025

RE: Structural Assessment Report with respect to the property located at:
Final Report
8320 SW 1 St
Pembroke Pines, FL 33025

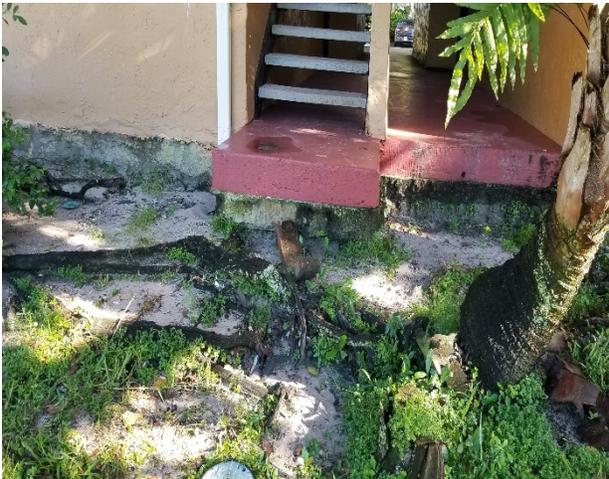
Photograph 9: Tree roots growing under foundation and soil washout

8. All trees and shrubs along the perimeter of the building must be removed along with its roots. The finish grade must be restored and compacted sloping away from the exterior wall in accordance with Florida building Code Section 1804.4.

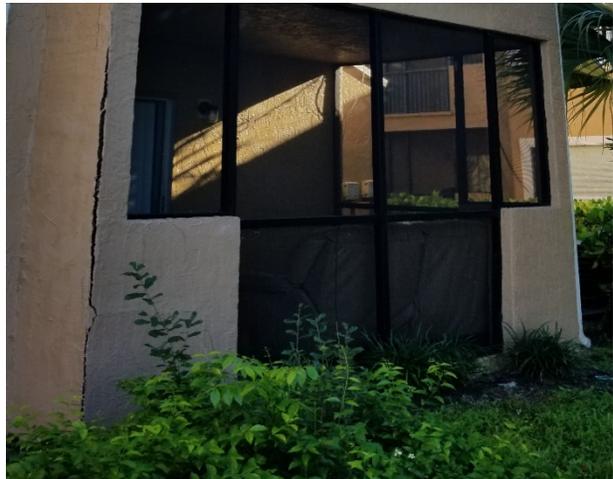
Photograph 10: Exterior wall cracking

2. Stucco along the perimeter walls must be stripped to the wood sheathing along the entire building.
3. The areas showing deteriorated sheathing and/or wood studs must be replaced. The remaining visibly sound structural framing must be evaluated by a special inspector.

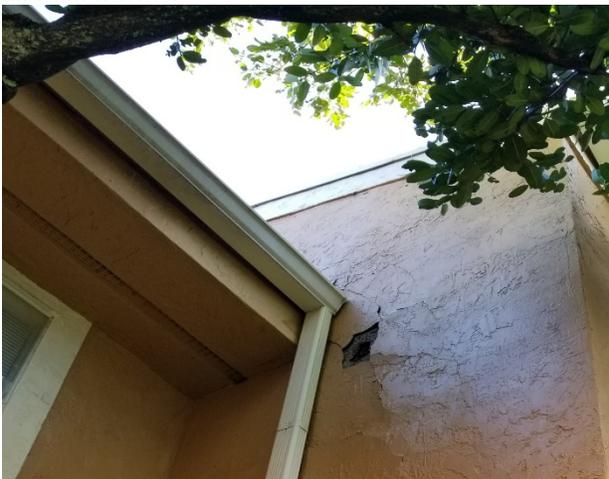
Photograph 11: Opening in the exterior wall

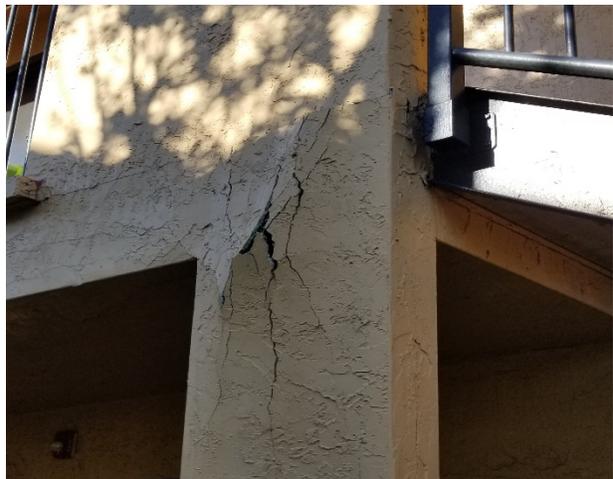
Wood column supporting the second-floor balcony (Photograph 12) was found to be in poor condition compromising the safety of the residents. Temporarily shoring system must be installed in accordance with plans and specifications. Not included as part of this report.

Photograph 12: Opening in the exterior wall. Shoring required

1. Temporarily shoring system in accordance with the plans and specifications must be installed immediately to support deteriorated column supporting a second-floor balcony (Photograph 12).

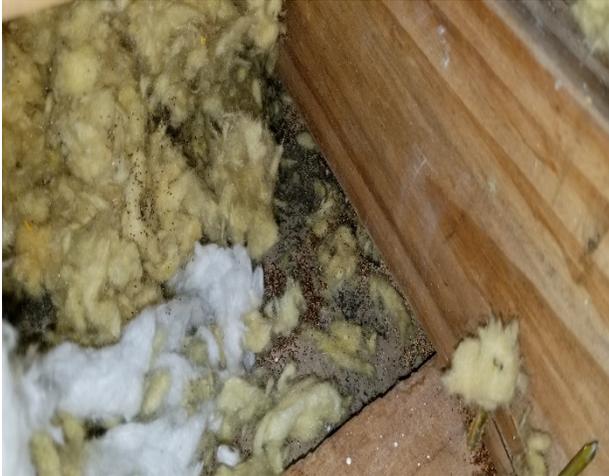
Photograph 13: Unit 208. Termites infestation

9. The entire building must be treated for termites prior to the repairs and inspected again for termites following the repairs. If termites persist, the building must be treated again.

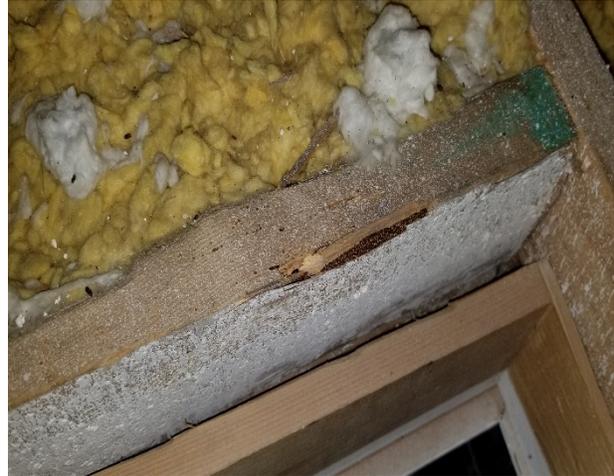
Photograph 14: Unit 206. Termites infestation
