Structural Assessment Report

8340 SW 3rd CT., BLDG 16
PEMBROKE PINES, FL 33025

RE: Structural Assessment Report with respect to the property located at:
Final Report
8340 SW 3 CT
Pembroke Pines, FL 33025

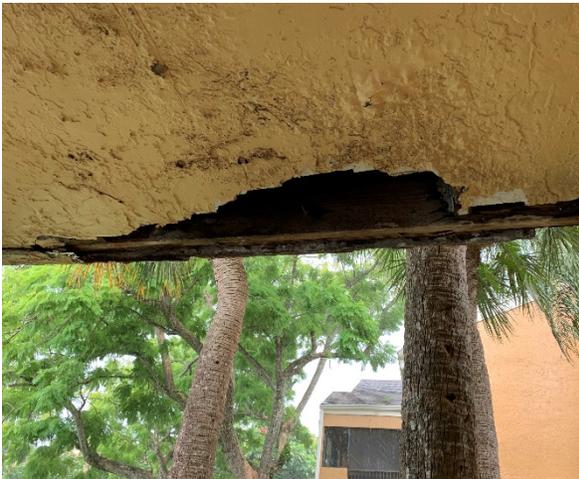
Upon completion of the structural assessment, balconies and cantilevered interior floors in units 101, 106, and 107 were found to be in poor condition compromising the safety of the residents. Temporarily shoring system must be installed in accordance with plans and specifications provided as a supplemental of this report.

Photograph 3: Unit 101. Shoring required

1. Temporarily shoring system in accordance with the plans and specifications must be installed immediately to support balconies and interior cantilever floors in Units 101, 106, and 107.

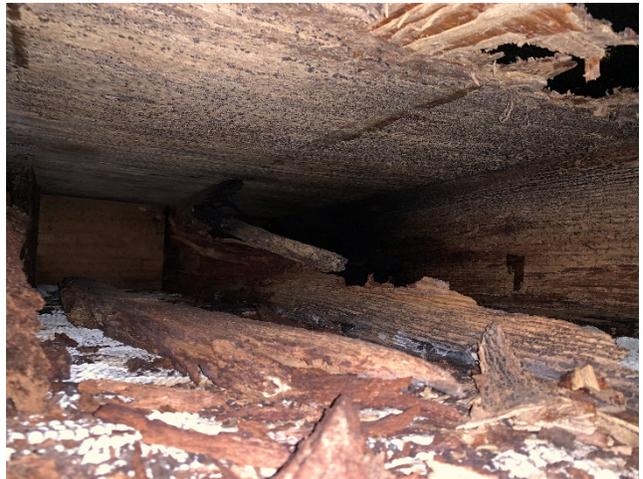
Photograph 4: Unit 101. Shoring required

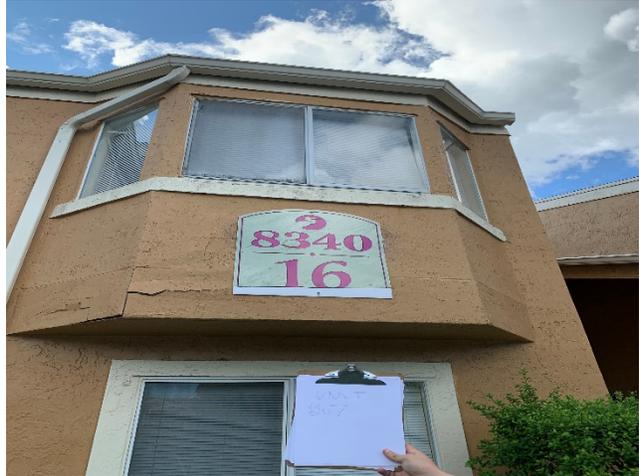
Photograph 8: Unit 107. Shoring required

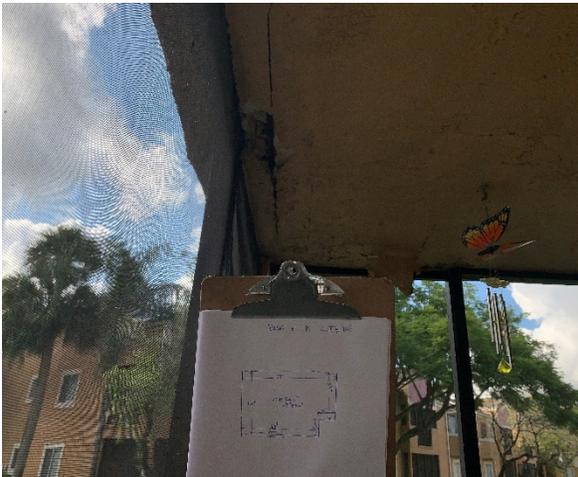
Photograph 13: Unit 106. Shoring required

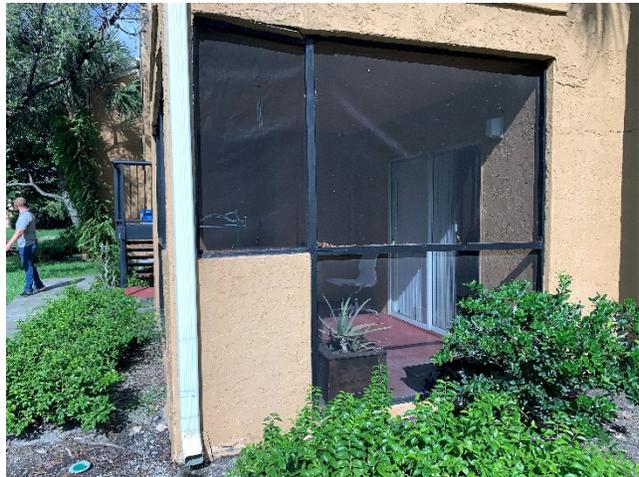
Photograph 14: Unit 106. Shoring required
