## Structural Assessment Report

164 SW 83 WAY BLDG. 3  
PEMBROKE PINES, FL 33025

**RE:** Structural Assessment Report with respect to the property located at:  
Final Report  
164 SW 83 Way  
Pembroke Pines, FL 33025

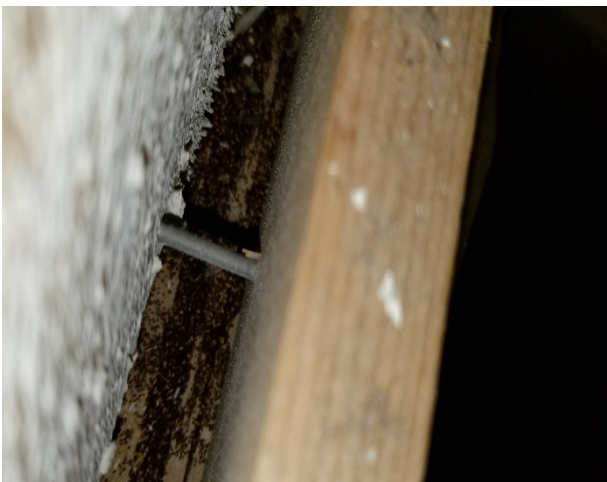
**Photograph 11: Unit 201. Termites infestation**

8. The entire building must be treated for termites prior to the repairs and inspected again for termites following the repairs. If termites persist, the building must be treated again.

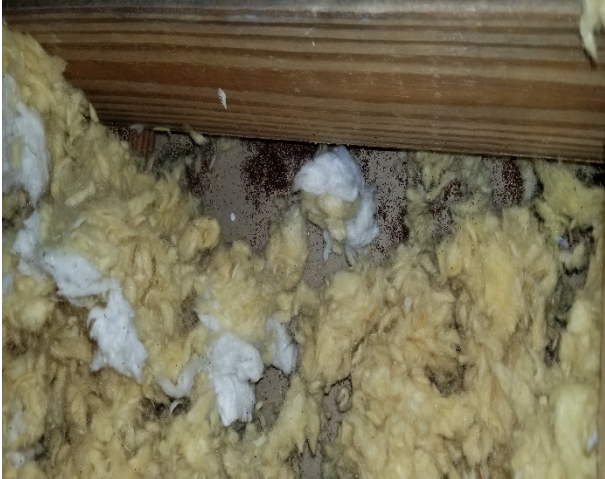
**Photograph 13: Unit 205. Termites infestation**

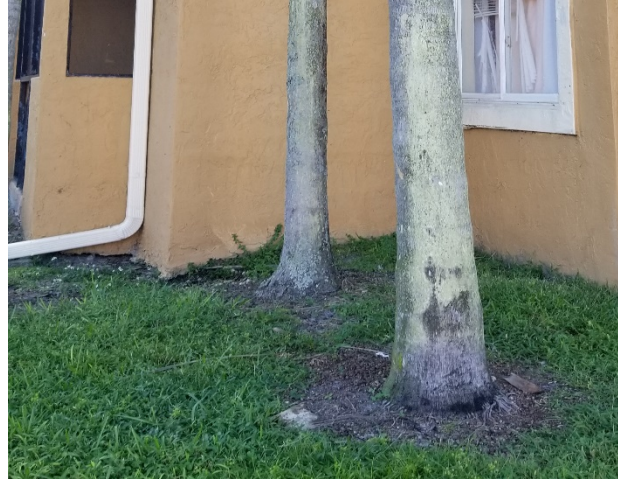
**Photograph 14: Tree roots growing against the foundation**

7. All trees and shrubs along the perimeter of the building must be removed along with its roots. The finish grade must be restored and compacted sloping away from the exterior wall in accordance with Florida building Code Section 1804.4.
