Structural Assessment Report

292 SW 83 WAY BLDG. 5
PEMBROKE PINES, FL 33025

RE: Structural Assessment Report with respect to the property located at:
Final Report
292 SW 83 Way
Pembroke Pines, FL 33025

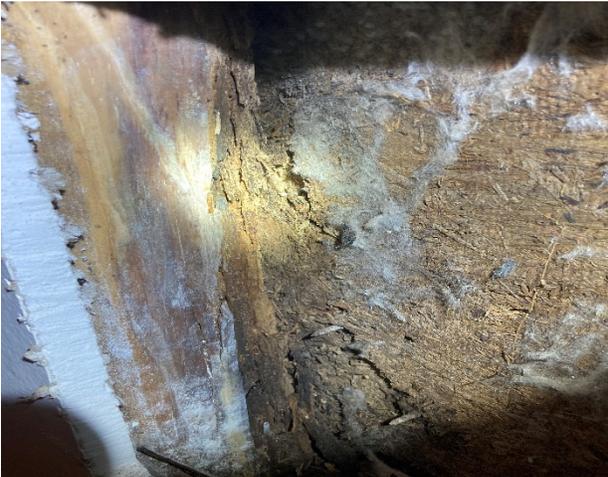
Photograph 3: Unit 101

Residents of several first-floor units reported multiple previous plumbing or a/c leaks underneath bathrooms and air handler closets of the second-floor units. In addition, at the time of this assessment, unit 101 Building 10 wood floor framing was exposed throughout the unit.

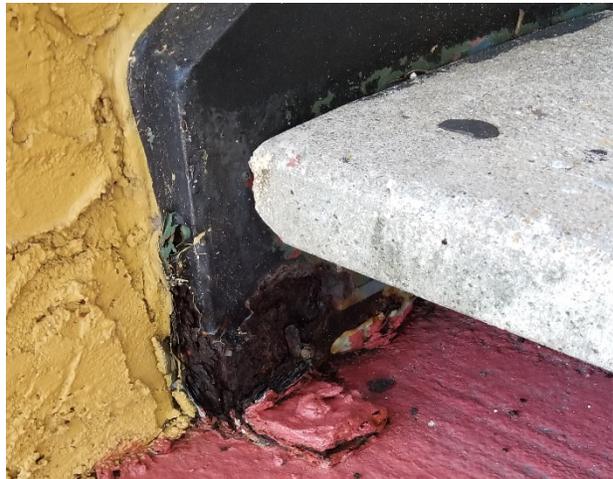
Photograph 8: Common areas staircase corroded connection

6. All household items stored in the attic space are a fire hazard and must be removed.
7. All staircases must be cleaned from corrosion, welded as needed, and painted. All cracked concrete steps must be replaced.

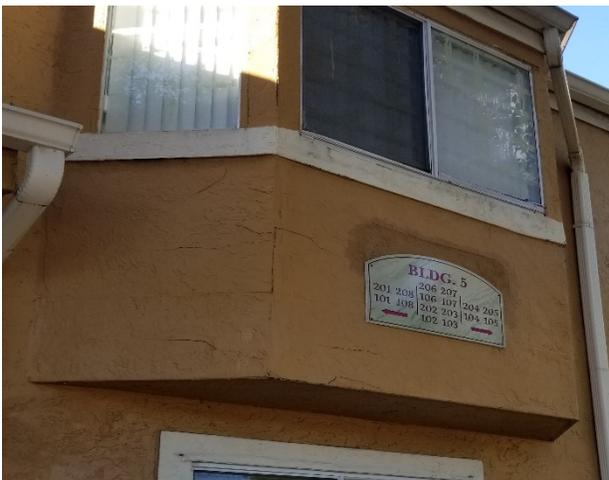
Wood column supporting the second-floor balcony (Photograph 11) and cantilevered interior floor (Photograph 9) were found to be in poor condition compromising the safety of the residents. Temporarily shoring system must be installed in accordance with plans and specifications. Not included as part of this report.

Photograph 9: Exterior wall cracks

1. Temporarily shoring system in accordance with the plans and specifications must be installed immediately to support deteriorated column supporting a second-floor balcony (Photograph 11) and interior cantilevered floor (Photograph 9).

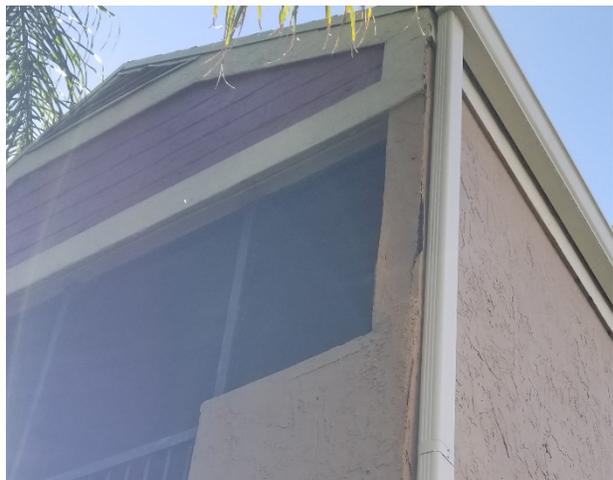
Photograph 10: Exterior wall cracks

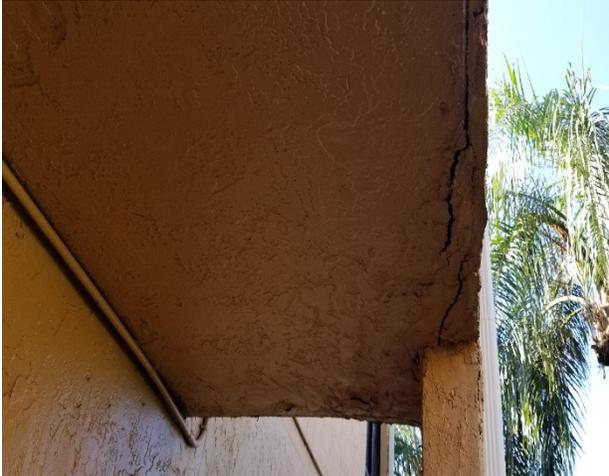
Photograph 11: Exterior wall cracks

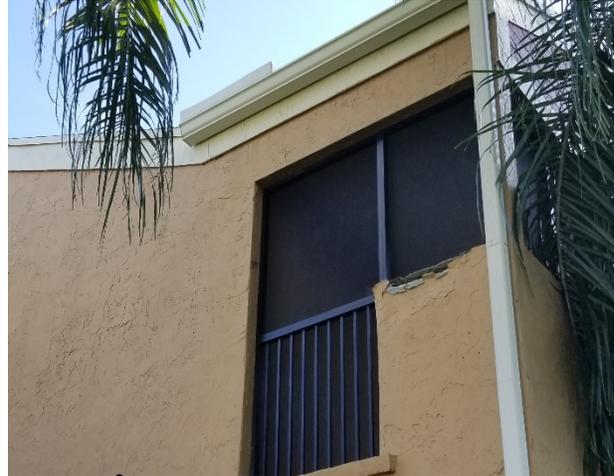
Photograph 12: Unit 208. Exterior wall opening
