## Structural Assessment Report

Building 8

8311 SW 5 Street

**Wednesday, October 13, 2021**

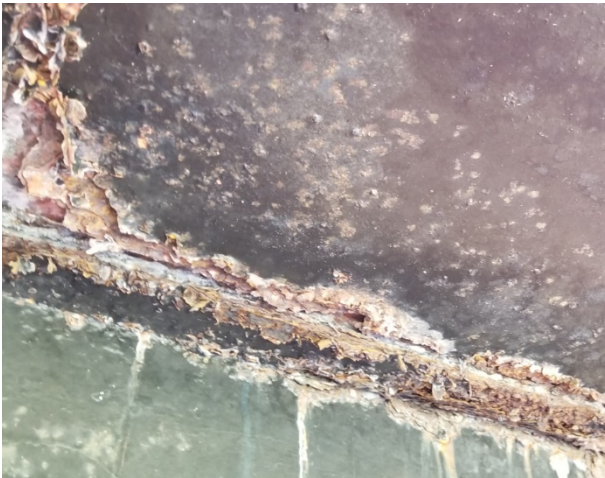
**Photograph 9: Extensive oxidization on the stairwell**

5. All household items stored in the attic space are a fire hazard and must be removed.
6. All staircases must be cleaned from corrosion, welded as needed, and painted. All cracked concrete steps must be replaced.

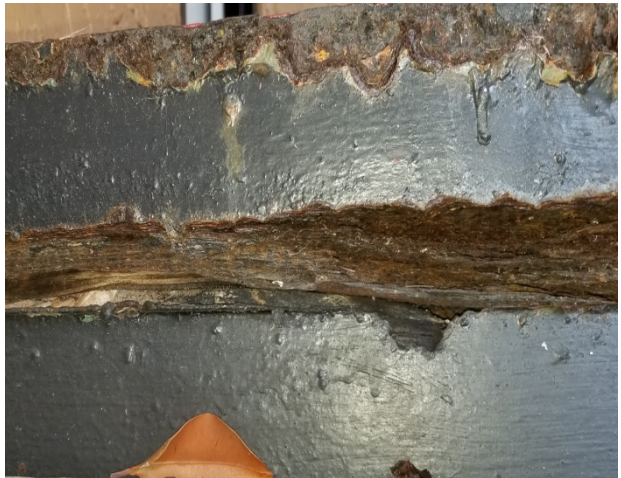
**Photograph 10: Unit 202. Oxidization on stairwell**

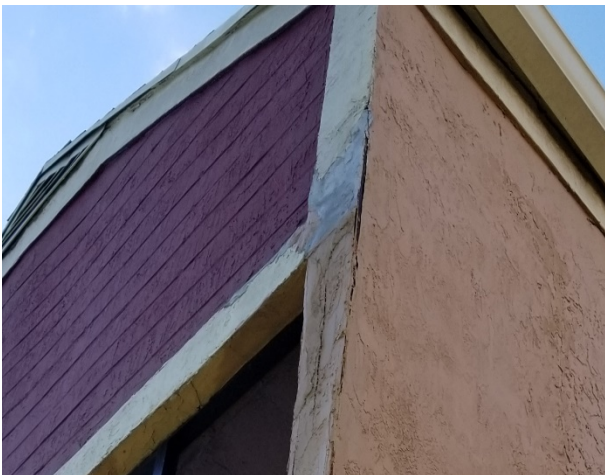
**Photograph 11: Cracks and previous repairs on the exterior wall**

1. Stucco along the perimeter walls must be stripped to the wood sheathing along the entire building.
2. The areas showing deteriorated sheathing and/or wood studs must be replaced. The remaining visibly sound structural framing must be evaluated by a special inspector.

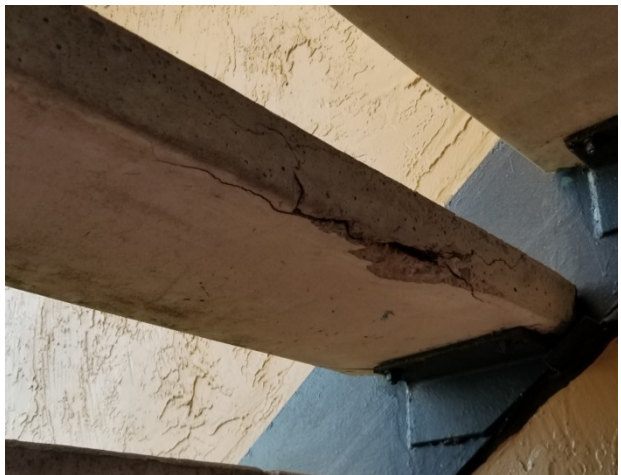
**Photograph 12: Cracks on the stairwell steps**

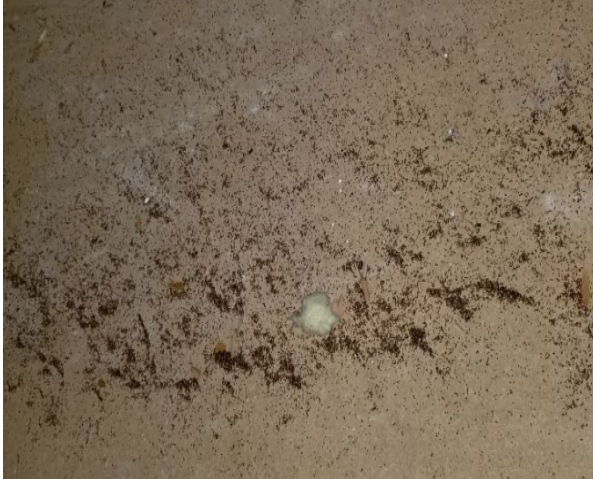
**Photograph 13: Unit 203. Termite infestation**

8. The entire building must be treated for termites prior to the repairs and inspected again for termites following the repairs. If termites persist, the building must be treated again.

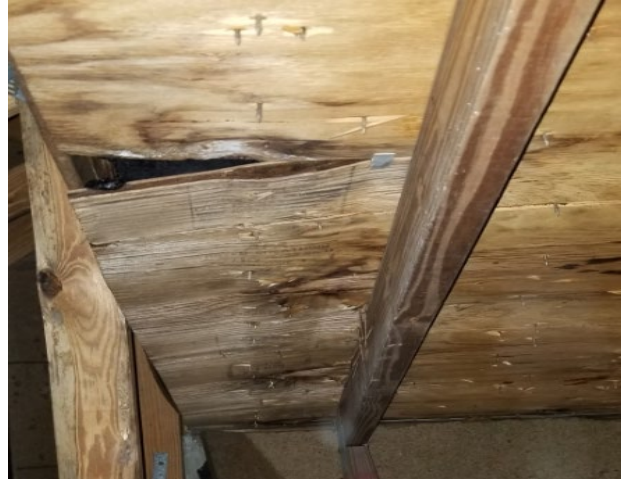
**Photograph 14: Unit 203. Moisture stains and cracked sheathing in the attic.**

3. The floor flat trusses must be exposed in all bathrooms and air handler closets. All moisture damaged framing must be repaired.
4. The insulation within the attic space must be vacuumed and all bottom chords of roof trusses must be inspected and repaired if found structurally damaged.
