## Structural Assessment Report

Building 9

8343 SW 5 Street

**RE:** Structural Assessment Report with respect to the property located at:  
8343 SW 5 Street  
Pembroke Pines FL 33025

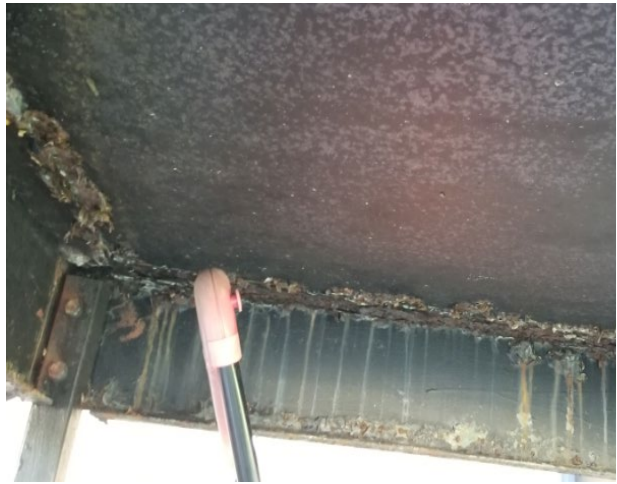
**Photograph 10: Oxidization underneath exterior stairwell**

5. All household items stored in the attic space are a fire hazard and must be removed.
6. All staircases must be cleaned from corrosion, welded as needed, and painted. All cracked concrete steps must be replaced.

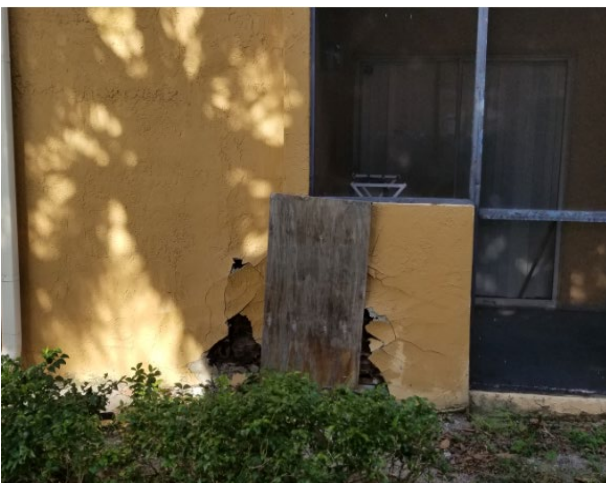
**Photograph 11: Opening in the exterior wall**

Install blue tarp over the wall opening of the first-floor unit (Photograph 11). The tarp must be hanging down from the roof line and covering the opening in the wall.

9. Install blue tarp over the wall opening of the first-floor unit (Photograph 11). The tarp must be hanging down from the roof line and covering the opening in the wall.

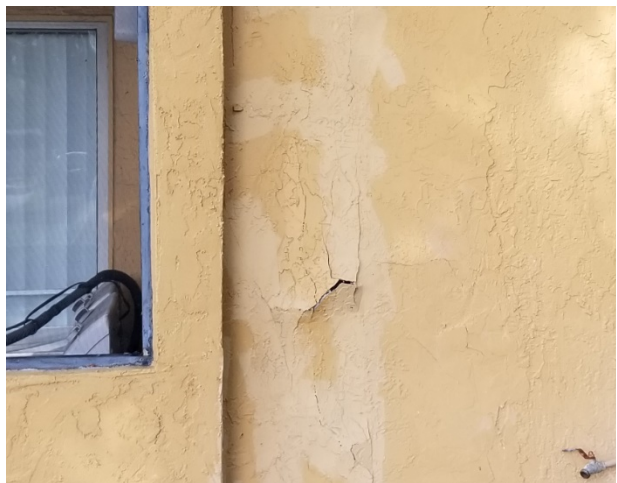
**Photograph 12: Exterior wall cracking**

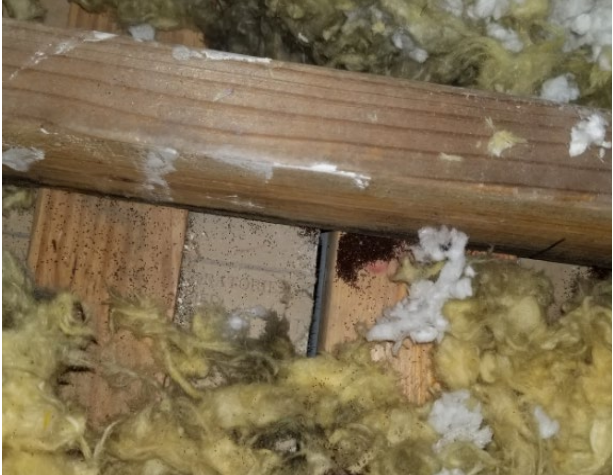
***Photograph 13: Unit 201. Termites infestation***

8. The entire building must be treated for termites prior to the repairs and inspected again for termites following the repairs. If termites persist, the building must be treated again.

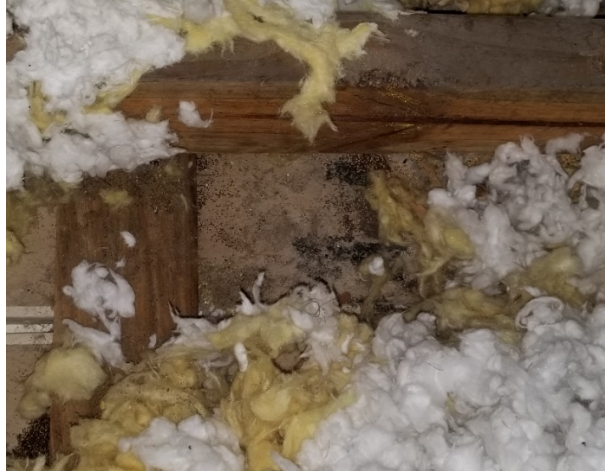
***Photograph 14: Unit 203. Termites infestation***
