Re: Heron Pond Condominium
Structural Conditions – Building #14

STRUCTURAL REPAIRS

164 SW 83rd CT.

BUILDING #14

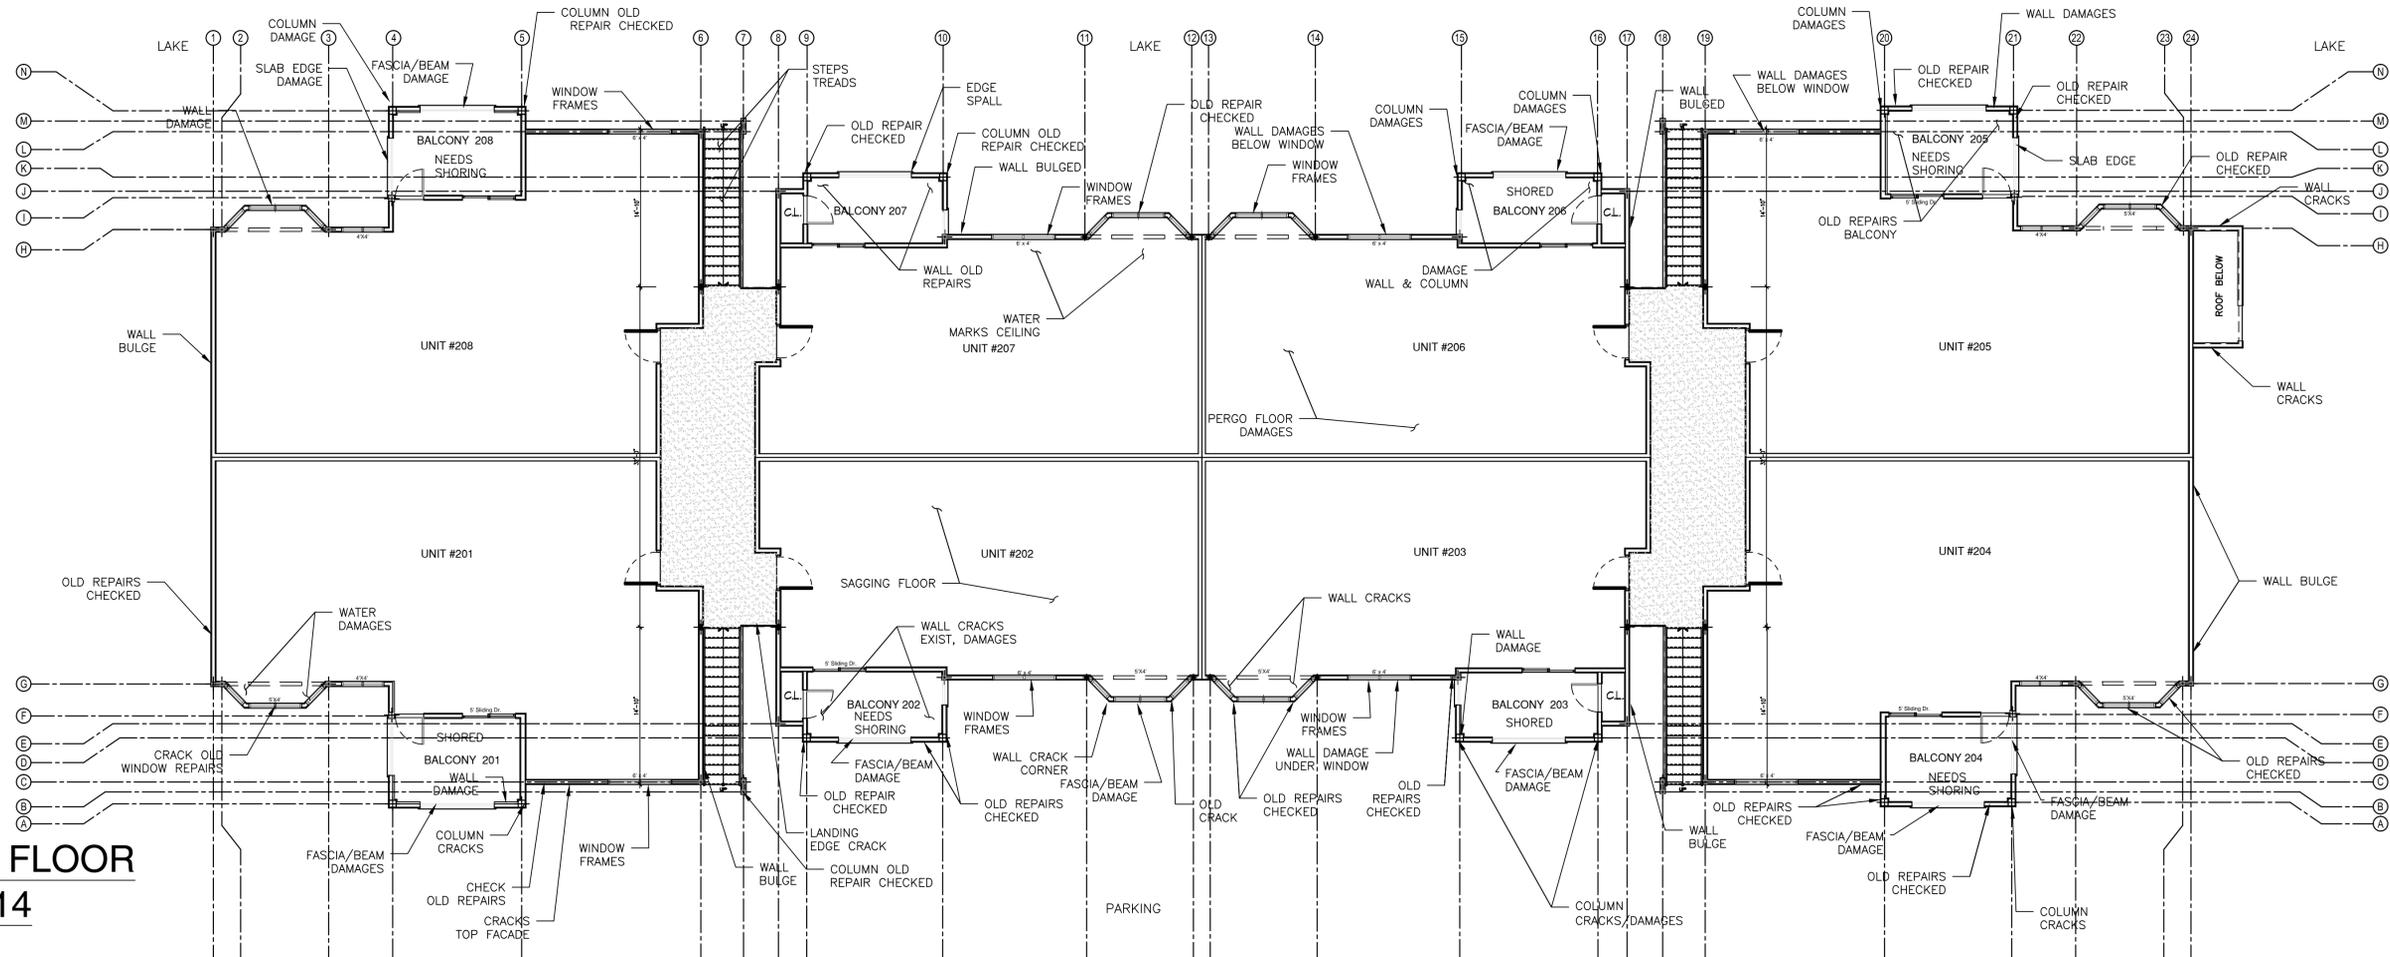
SECOND FLOOR
BLDG. #14

- There are signs of water damage at the bay window of Unit #201.
- There is a section of sagging floor in Unit #202.
- The flooring in Unit #206 shows signs of damage that may reflect structural issues underneath.

- There are water marks in the ceiling of Unit #207.
- There are cracks in the ceiling of Unit #103.
- There are signs of termite and water damage in both Units #105 and #106.

- There are at least 94 different locations around the building where damage has been visually detected, involving all 16 units.
- Additionally, signs of previous repairs have been noted at 21 other locations around the building.

- There are signs of damage visible on all eight (8) balcony stacks.
- There are signs of damage to sections of exterior walls that appear to carry significant second floor and roof loads.

- There are at least two (2) locations where damage has been observed in sections of the structure that clearly appear to have been recently repaired; in these locations fresh signs of damage are telegraphing through the finishes.

- The water damage in Unit #201 may be a sign that significant structural damage exists.
- The sagging floor section in Unit #202 is very likely a sign of weakened floor joists below.
- The fact that the Pergo flooring in Unit #206 is damaged may hint at structural concerns beneath the flooring.
- Water marks in the ceiling of Unit #207 suggest that water has penetrated the roof and found its way to the ceiling, and therefore, the trusses above as well, maybe damaging them.
- Cracks in the ceiling of Unit #103 may reflect differential deflections between equally loaded adjacent joists, a sign of damaged, weakened joists.

- The termite damage and water damage in Units #105 and #106 create suspicion that water and termite damage may also exist in the floor joists that are located directly above.
- Damage sustained by the exterior structural components, in the form of termite and water related wood deterioration, is clearly significant; the likelihood of termite and/or water related damage extending into the building's interior is considerable.
- Of additional concern is that approximately 10% of recently repaired sections are already showing new signs of deterioration.
- All of the balcony stack structures, including joists, beams, and columns, have sustained significant structural damage.
- Some of the apparently compromised sections of exterior wall appear to carry considerable 2nd floor and/or roof loads.

- The flooring and/or the ceiling should be removed, as required, to address the noted damages in Units #201, #202, #103, #105, #106, #206, and #207.
- All access to all balconies (both levels) must be eliminated until repairs have been made.
- All balcony ceilings should be removed to allow for visual observations of the second floor and roof structures.
- All second-floor balcony structures should be rebuilt.
- All roof trusses over the second-floor balconies shall be repaired as required.
- Damages that extend into the interior of the building must be identified and repaired upon discovery.
- Wall bulges, cracks, and delaminations must be removed and those wall sections repaired in accordance with the loads that they carry.
- Based on findings from the explorations to be performed, as described directly above, individual units may need to be completely vacated.
