Re: Heron Pond Condominium
Structural Conditions – Building #16

STRUCTURAL REPAIRS

BUILDING #16

HERON POND CONDOMINIUMS
164 SW 83rd CT. - BUILDING 16
PEMBROKE PINES, FL 33025
COVER PAGE & INDEX

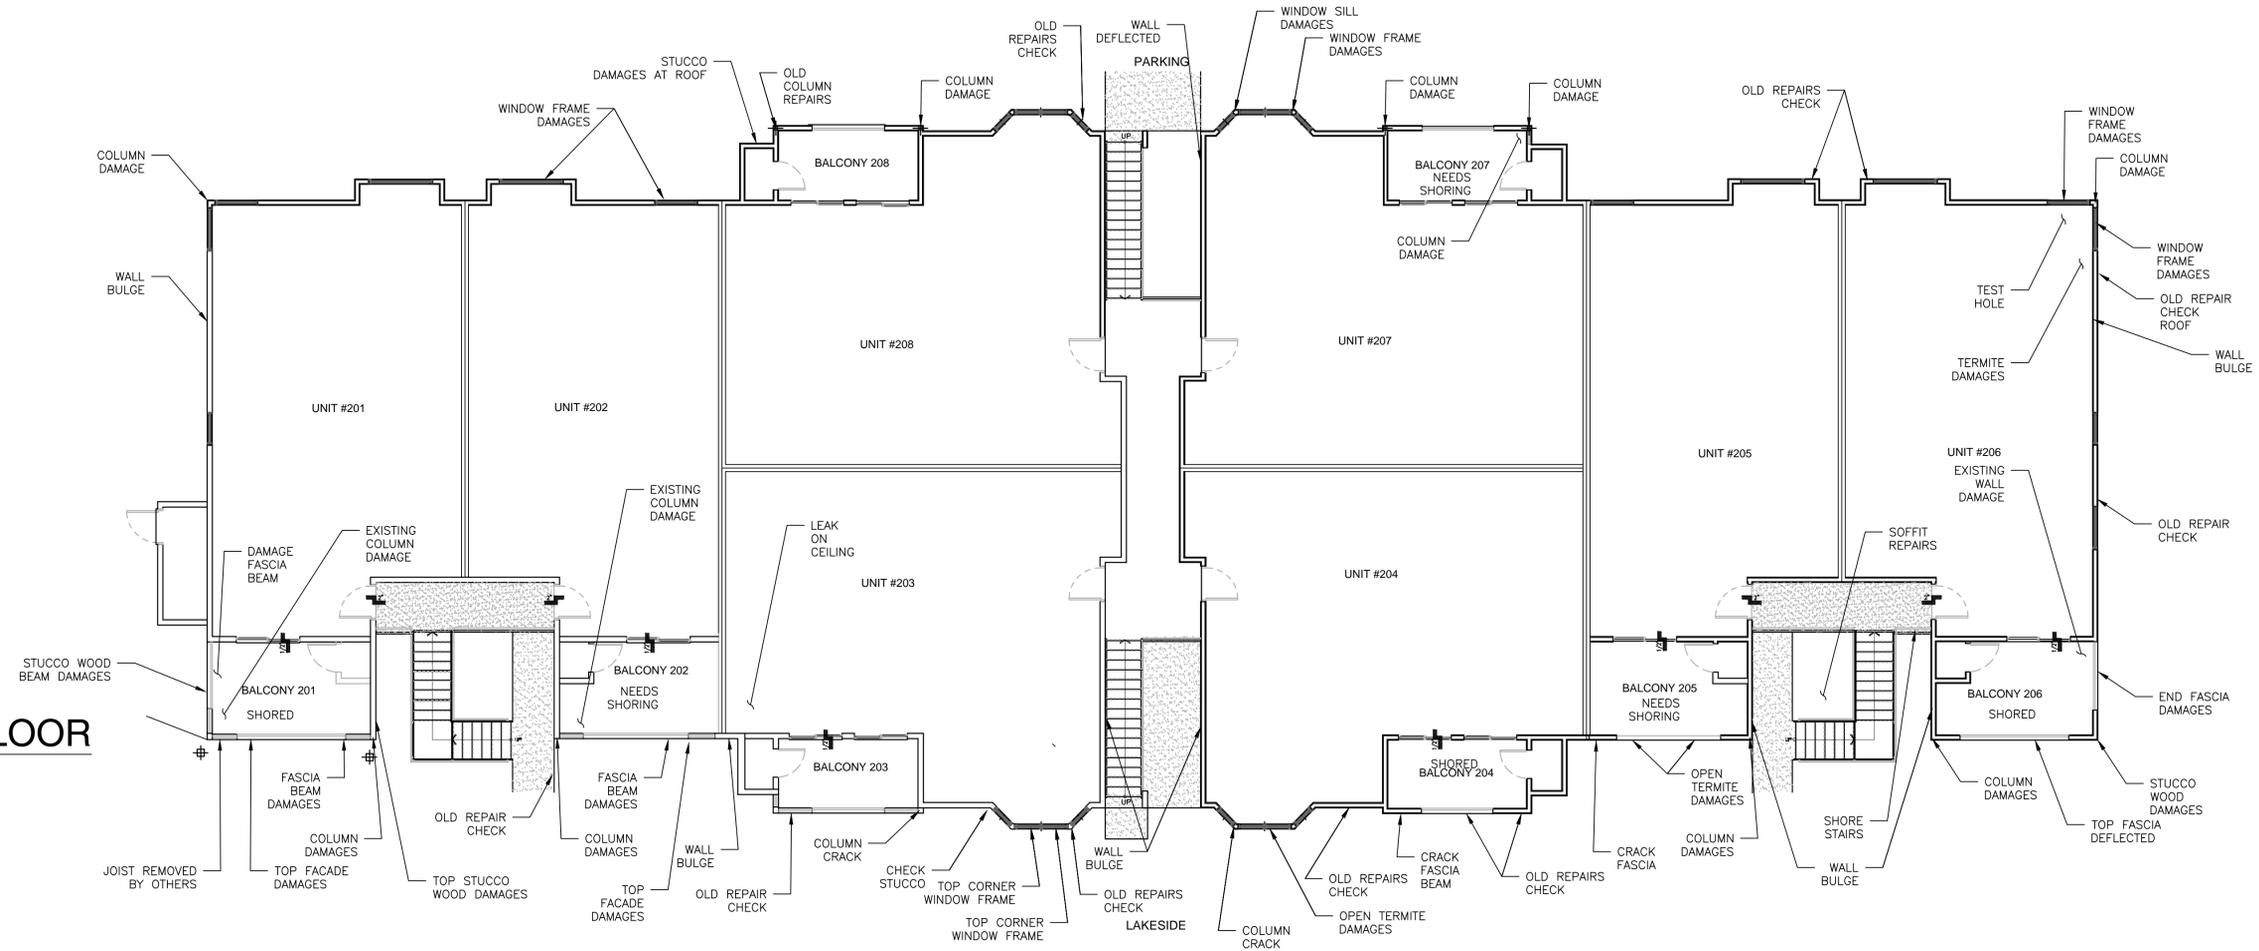
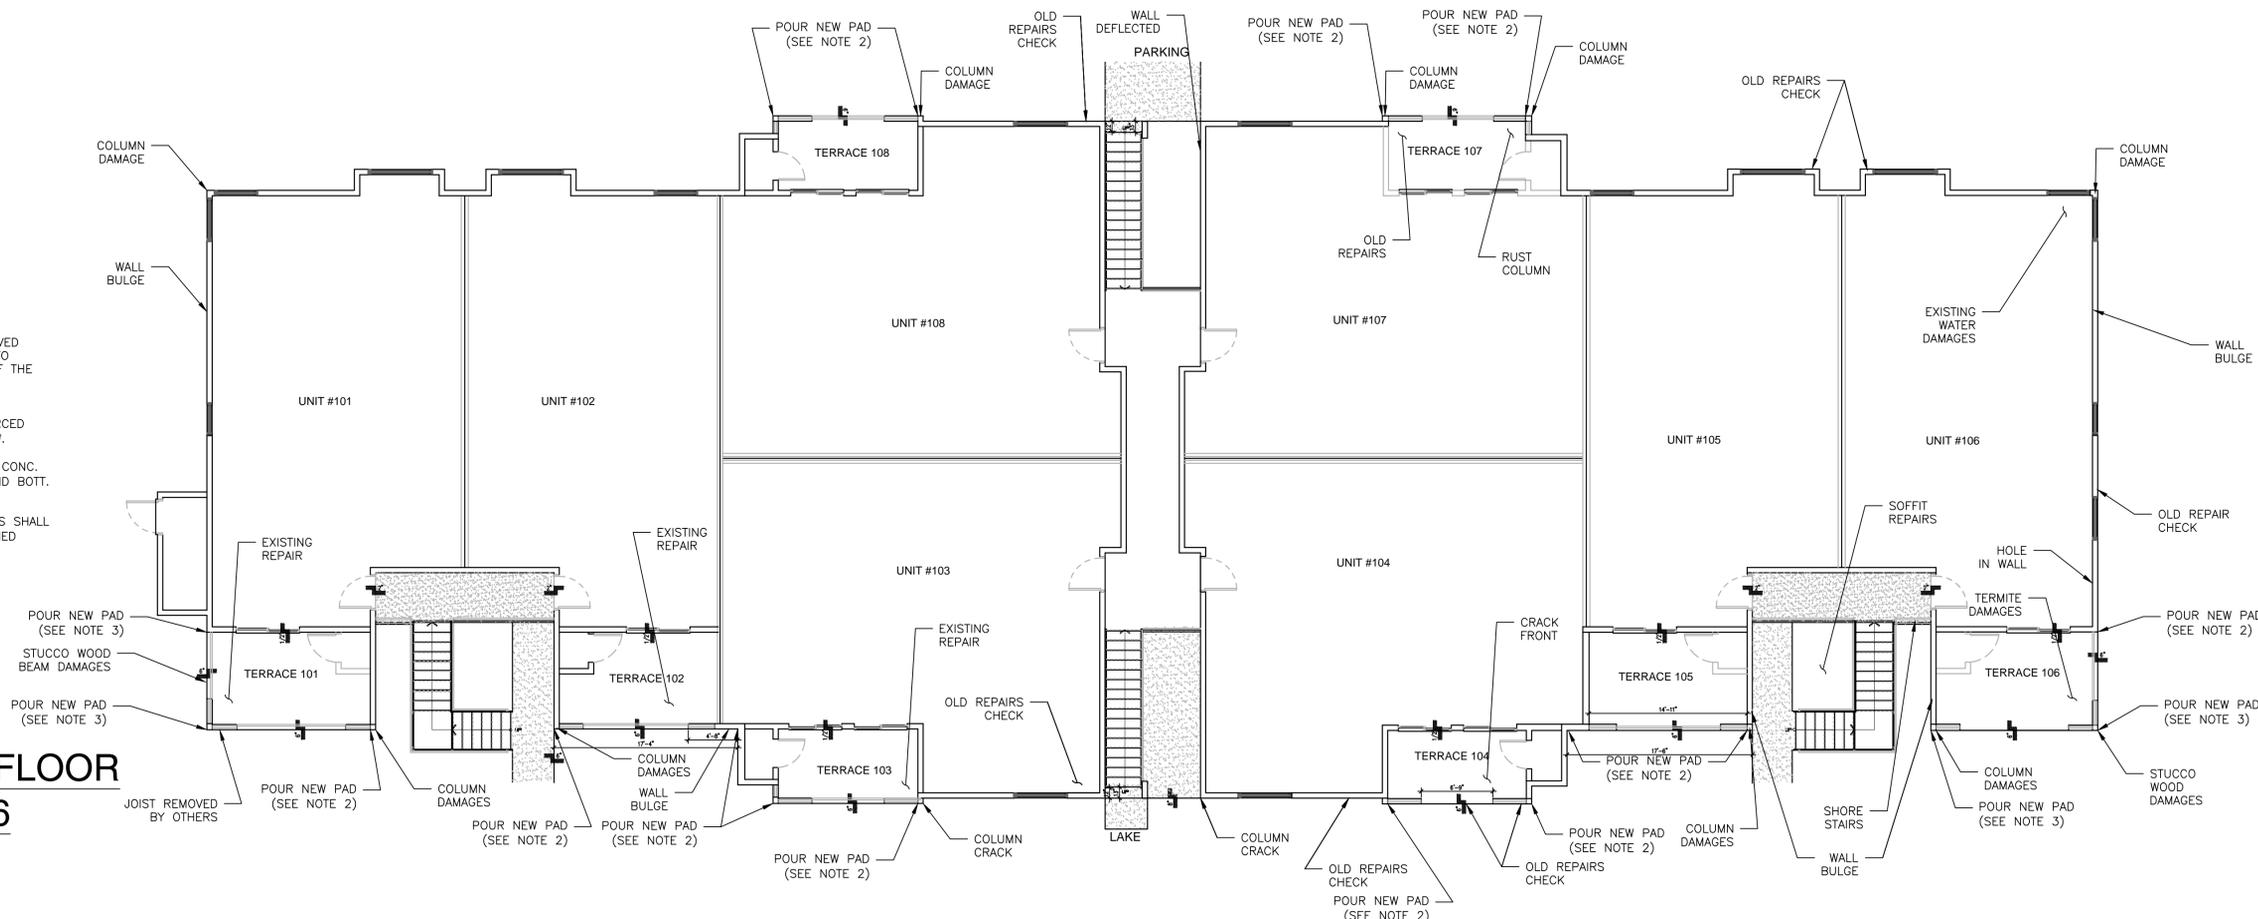
- Water marks were signs of a leak above the ceiling in Unit #203.
- There were signs of termite damage in Unit #208.
- There are signs of existing water damage in Unit #108.
- There are at least 77 different locations around the building where damage has been visually detected, involving all 16 units.
- Additionally, signs of previous repairs have been noted at 21 other locations around the building.
- There are signs of damage visible on all eight (8) balcony stacks.
- There are signs of damage to sections of exterior walls that appear to carry significant second floor and roof loads.

- The trusses above the ceiling of Unit #203 may have also been negatively affected by the leak.
- The damages in Units #108 and #208 may be telegraphing hidden structural damages.
- Damage sustained by the exterior structural components, in the form of termite and water related wood deterioration, is clearly significant; the likelihood of termite and/or water related damage extending into the building's interior is considerable.
- All of the balcony stack structures, including joists, beams, and columns, have sustained significant structural damage.
- Some of the apparently compromised sections of exterior wall appear to carry considerable 2nd floor and/or roof loads.

- The ceiling of Unit #203 should be removed to allow for observation of the trusses above.
- The flooring/ceiling in Units #108 and #208 should be removed to allow for investigation of the hidden structural elements.

- All access to all balconies (both levels) must be eliminated until repairs have been made.
- All balcony ceilings should be removed to allow for visual observations of the second floor and roof structures.
- All second-floor balcony structures should be rebuilt.
- All roof trusses over the second-floor balconies shall be repaired as required.
- Damages that extend into the interior of the building must be identified and repaired upon discovery.
- Wall bulges, cracks, and delaminations must be removed and those wall sections repaired in accordance with the loads that they carry.
- Based on findings from the explorations to be performed, as described directly above, individual units may need to be completely vacated.
