October 9th, 2023

Re: Heron Pond Condominium
Structural Conditions – Building #11

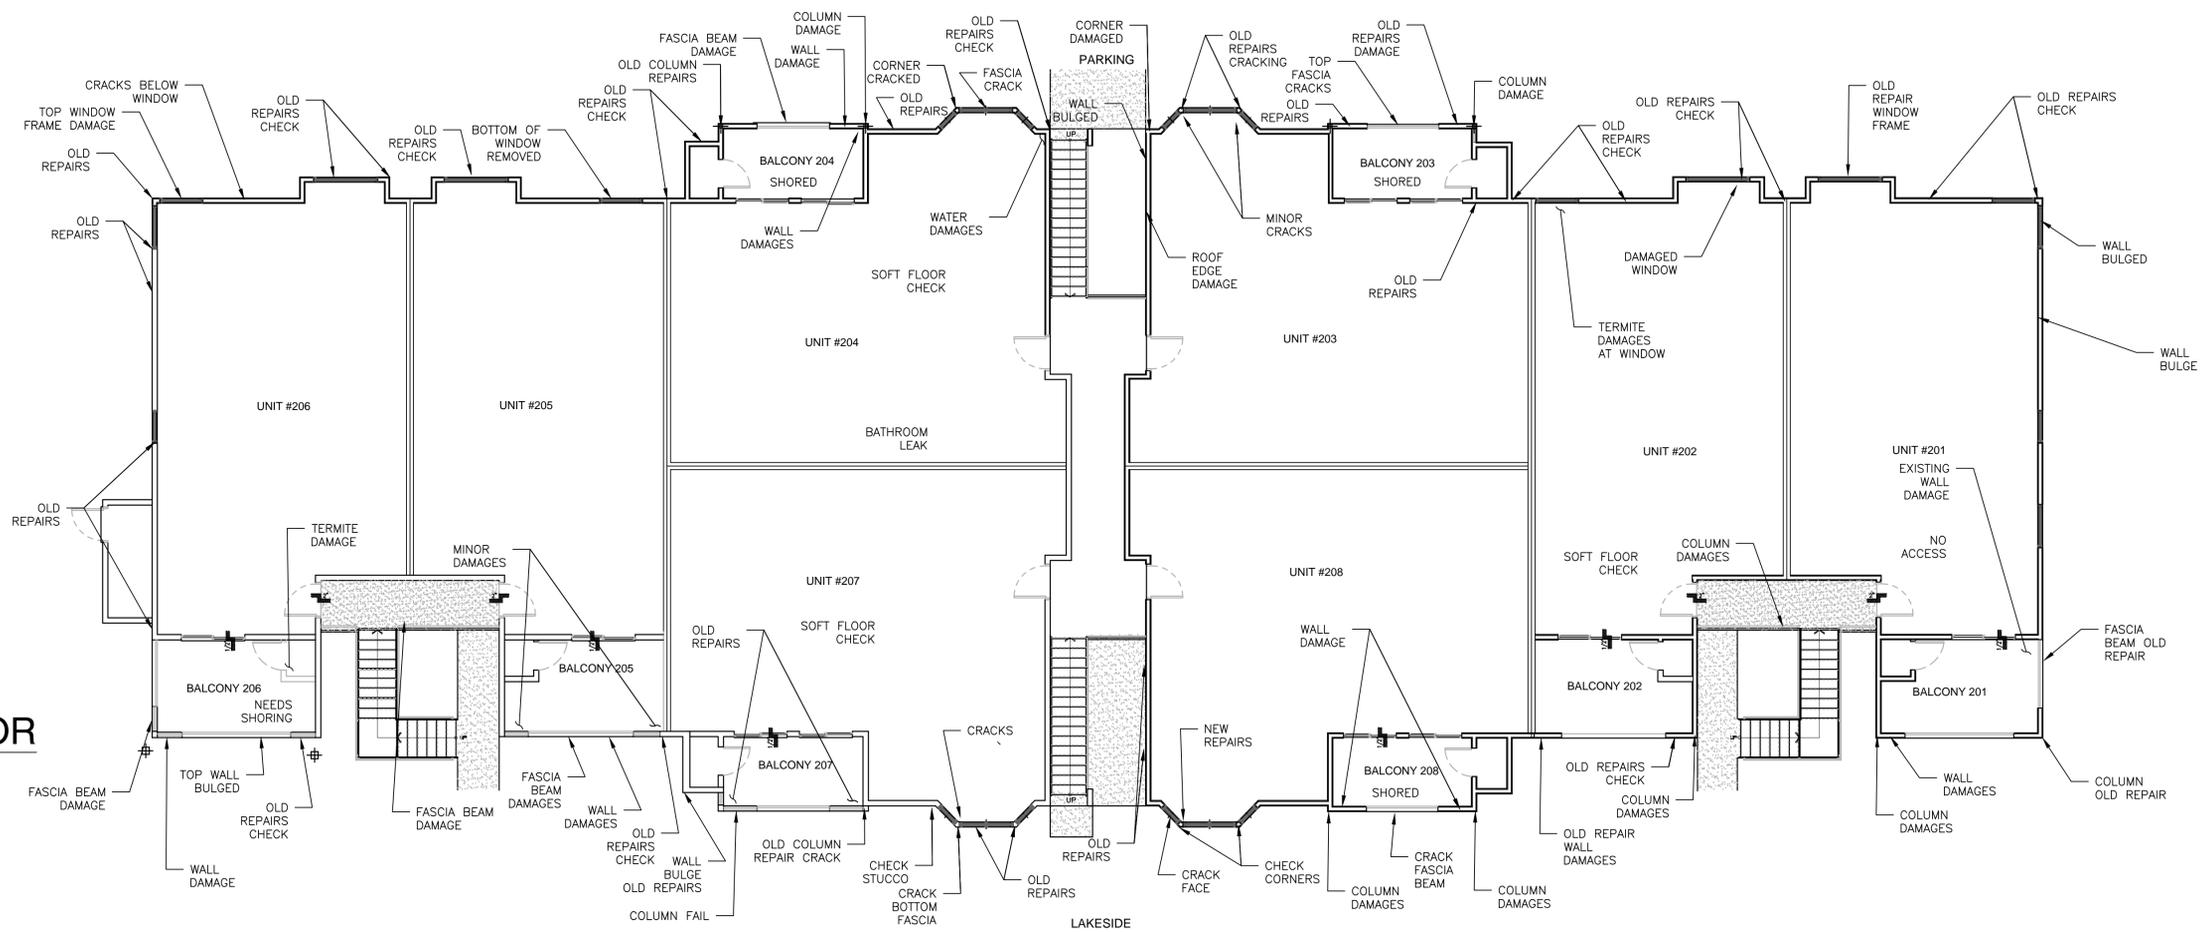
**SECOND FLOOR
 BLDG. #11**

- Three of the balconies are shored (#203, #204, and #208) with a fourth one (#206) appearing to need shoring.
- The floors in portions of Units #202, #204, and #207 exhibited signs of excessive deflections from simple pedestrian foot traffic.

- Water damage was observed in the corner of Unit #204.
- Termite damage was observed at a window in Unit #202.
- Cracks were observed at the interior wall face at the bay window in Unit #207.

- The balcony for Unit #206 requires shoring.
- The “soft” (flexing) floors in Units #202, #204, and #207 are likely signs of weakened floor joists.
- The signs of water damage observed in the corner of Unit #204, the termite damage in Unit #202, and cracking of the interior wall finishes in Unit #207 may all have resulted in sections of weakened wall.
- Of additional concern is that approximately 12% of recently repaired sections are already showing new signs of deterioration.
- Damage sustained by the exterior structural components, in the form of termite and water related wood deterioration, is clearly significant; the likelihood of termite and/or water related damage extending into the building’s interior is considerable.

- The balcony for Unit #206 shall be shored as other balconies in need of shoring have been shored.
- Sections of floor sheathing should be removed as required in the areas showing weakness noted in Units #202, #204, and #207.

- Units #202, #204, #207, and those directly below (Units #102, #104, and #107) shall be vacated. The remaining units, to the best of my knowledge, based on our visual inspection of finishes, are deemed to be safe to inhabit as of this date.
