October 20th, 2023

Re: Heron Pond Condominium
Structural Conditions – Building #8

Over the last couple of weeks, a representative of ACG Engineering Services, Inc. (ACG), acting on my behalf, has surveyed Building #8 at the Heron Pond Condominium complex. We have attached a copy of Sheet S-3.0, which will be part of our permit set, since it reports our structural survey findings.

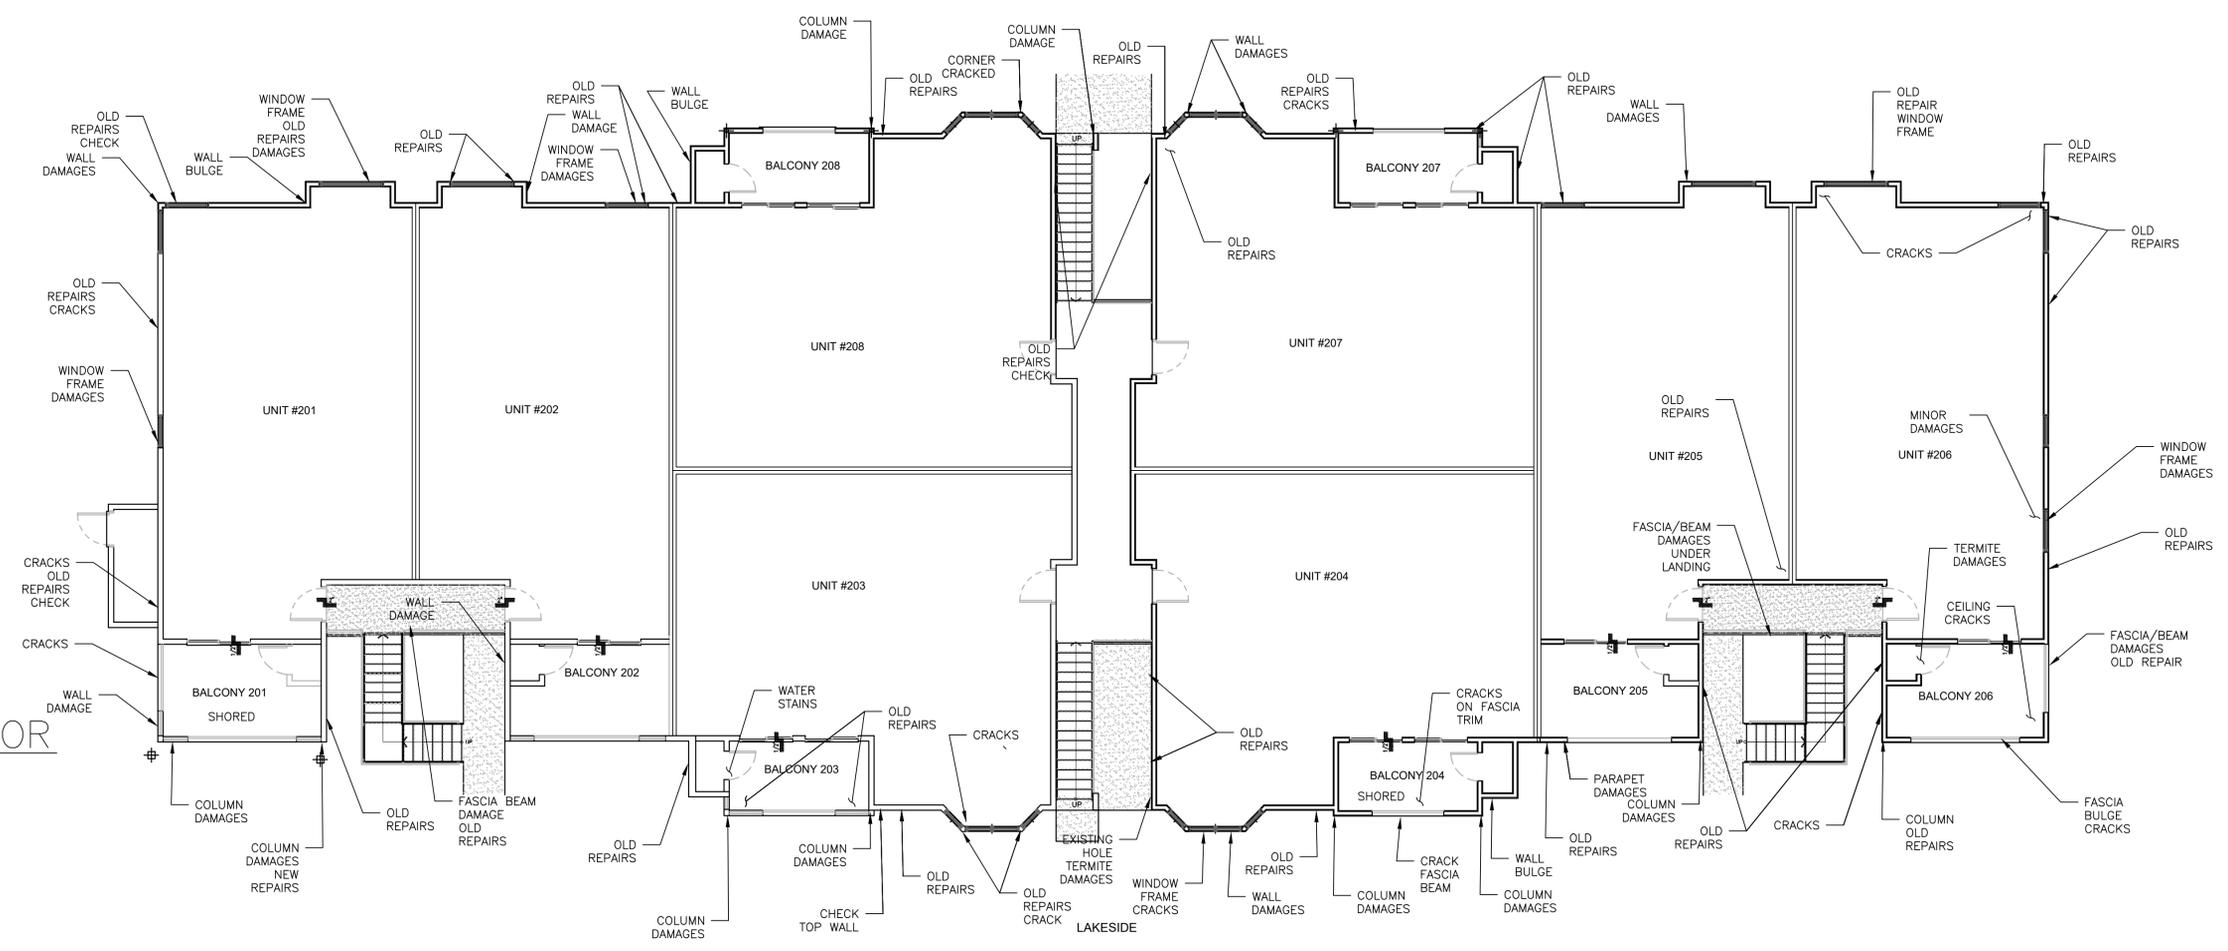
SECOND FLOOR
BLDG. #8

- Two of the balconies are shored (#201 and #204) with at least one more (#206) appearing to need shoring.
- Signs of water damage were observed in Units #101, #102, #104, and #106.

- Termite damage was observed in Unit #101 and on the balcony of Unit #206.
- Ceiling damage was noted on the balcony for Unit #206.
- There are at least 41 different locations around the building where damage has been visually detected, involving all 16 units.

- The balcony for Unit #206 requires shoring.
- The signs of water damage observed in Units #101, #102, #104, and #106 may all reflect sections of weakened wall.
- The ceiling damage in Unit #206 must be investigated to determine if there is any truss damage to be addressed.
- Of additional concern is that approximately 22% of recently repaired sections are already showing new signs of deterioration.

- The balcony for Unit #206 shall be shored as other balconies in need of shoring have been shored.
- All access to all balconies (both levels) should be prohibited until repairs have been made.

- All balcony ceilings should be removed to allow for visual observations of the second floor and roof structures.
- All second-floor balcony structures should be repaired as required.

- All roof trusses over the second-floor balconies shall be repaired as required.
- Damage that extends into the building's interior must be identified and repaired upon discovery.
