November 6th, 2023

Re: Heron Pond Condominium
Structural Conditions – Building #1

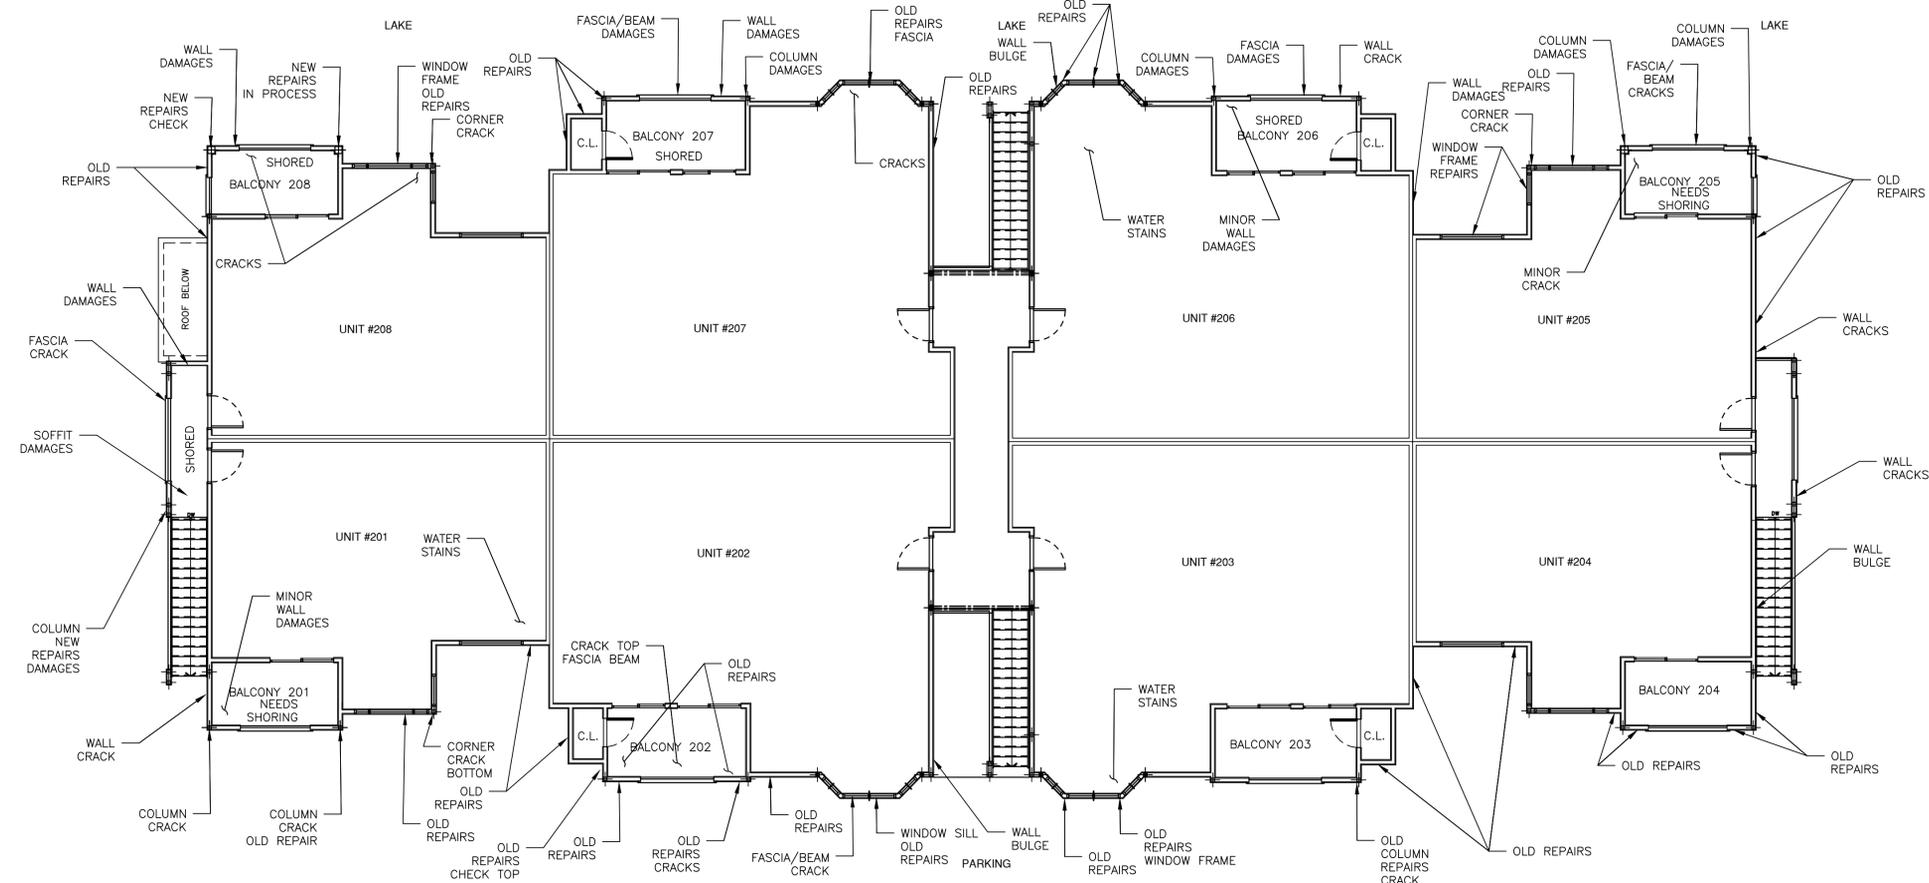
SECOND FLOOR
BLDG. #1

- Three of the balconies are shored (#206, #207, and #208) with two additional ones (#201 and #205) appearing to need shoring.
- Signs of water damage were observed in Units #103, #104, #107, #201, #203, and #206.

- There are at least 32 different locations around the building where damage has been visually detected, involving all 16 units.
- Additionally, signs of previous repairs have been noted at 35 other locations around the building.

- There are signs of damage or old repairs visible on all eight (8) balcony stacks.
- There are signs of damage to sections of exterior walls that appear to carry significant second floor and roof loads.

- There are five (5) locations where damage has been observed in sections of the structure that clearly appear to have been previously repaired; in these locations fresh signs of damage are telegraphing through the finishes.

- The balconies for Units #201 and #205 require shoring.
- The signs of water damage observed in Units #101, #103, #104, #201, #203, and #206 may reflect sections of weakened structure.
- Damage sustained by the exterior structural components, in the form of water-related wood deterioration, is clearly significant; the likelihood of water-related damage extending into the building's interior is considerable, but at the present time does not appear to pose a safety concern for persons or property.
- Most of the balcony stack structures, including joists, beams, walls, and columns, appear to have sustained at least some past or present structural damage. Thus, we recommend that the balconies should be shored and that all access should be prohibited.

- The balconies for Units #201 and #205 shall be shored as other balconies in need of shoring have been shored.
- All access to all balconies (both levels) should be prohibited until repairs have been made.

- All balcony ceilings should be removed to allow for visual observations of the second floor and roof structures.
- All second-floor balcony structures should be repaired as required.

- All roof trusses over the second-floor balconies shall be repaired as required.
- Damage that extends into the building's interior must be identified and repaired upon discovery.

- Areas where signs of water damage or leaks have been noted shall be exposed and repaired as required.
- Wall bulges, cracks, and delaminations must be removed and those wall sections repaired in accordance with the loads that they carry.
