November 28<sup>th</sup>, 2023

Re: Heron Pond Condominium  
Structural Conditions – Building #1  
Updated Findings

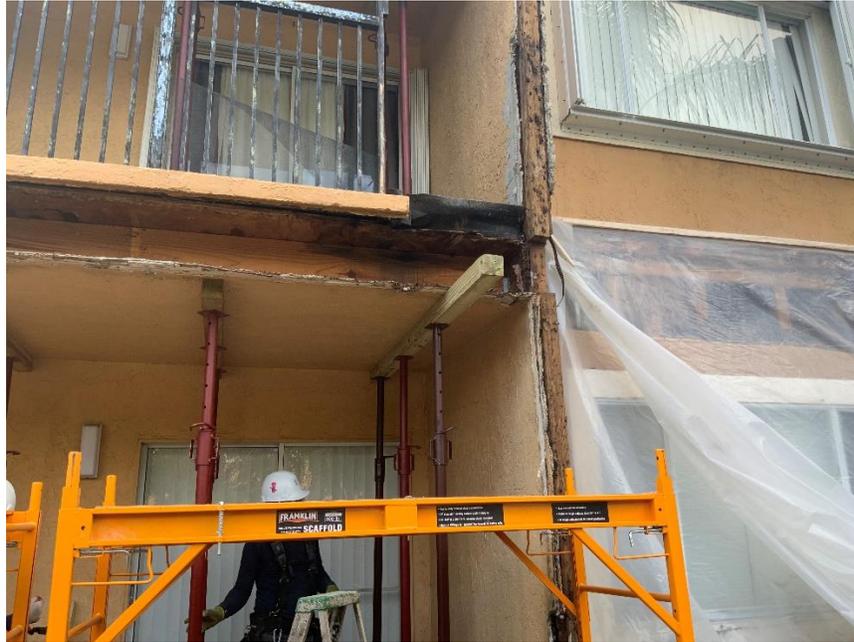
Photo #1 – Removed Severely Damaged Exterior Balcony Beam/  
Revealing Adjacent Joist with Only Limited Damage

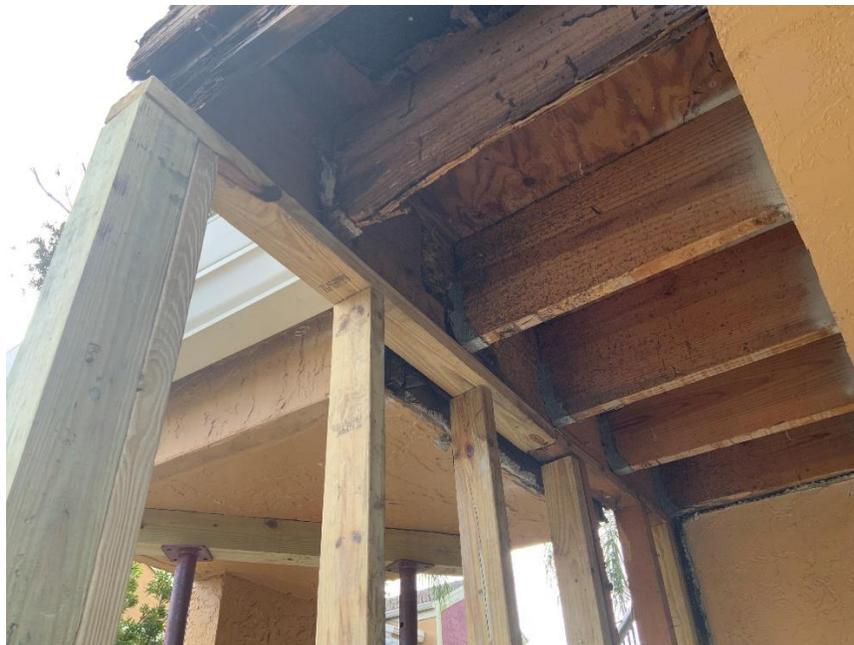
- Even the balcony damage appears to lessen as the affected structural members get further away from the outside balcony edges.
- A number of the building corners have sustained significant structural damage.

Photo #2 – Progression of Joist Damage/Each Joist, Moving in from  
The Edge, Shows Less and Less Damage

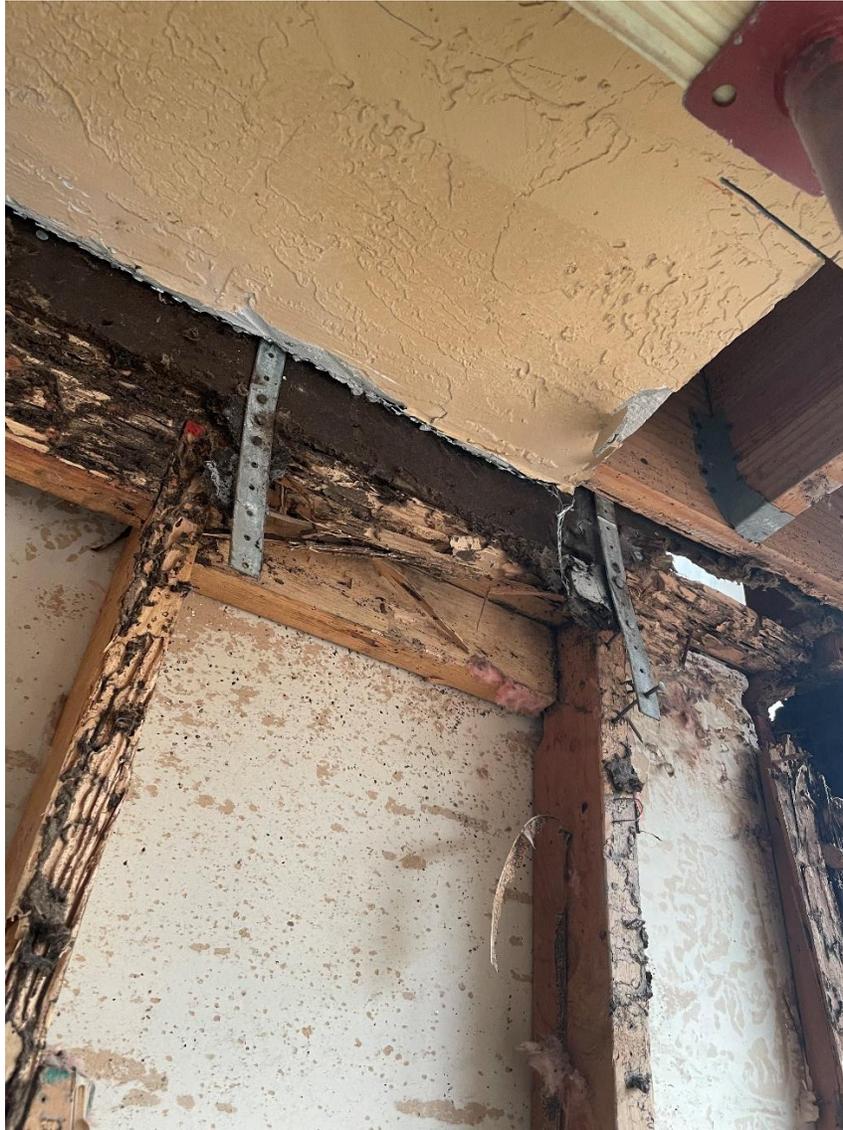
- The termite damage to the exterior walls appears to have originated with the paneling used as exterior sheathing. Termite “tunneling” appeared to run in between the inside face of the paneling and the exterior faces of the wall 2x4 members.

Photo #3 – Damage to Vertical Wall 2x4, Showing Termite “Tunneling”  
Damage with the Deterioration on the 2x4 Face Adjacent to  
The Exterior Panel (Not Shown)

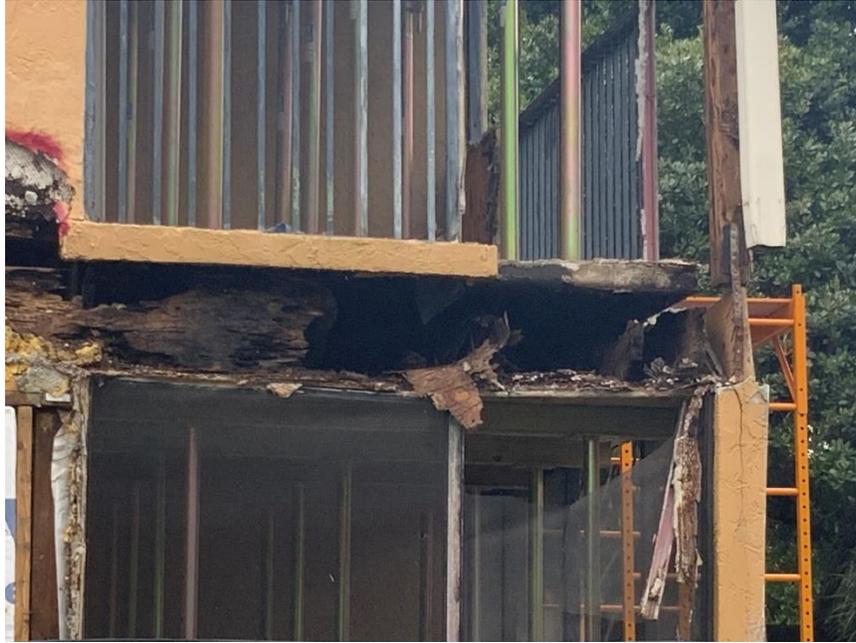
- The balconies, the portions of the building structures permanently and fully exposed to the weather and elements, have sustained the worst of the wood damage.

Photo #4 – The Exterior Balcony Beam Has Been Completely Damaged And Removed/This Balcony Structure Damage is Severe

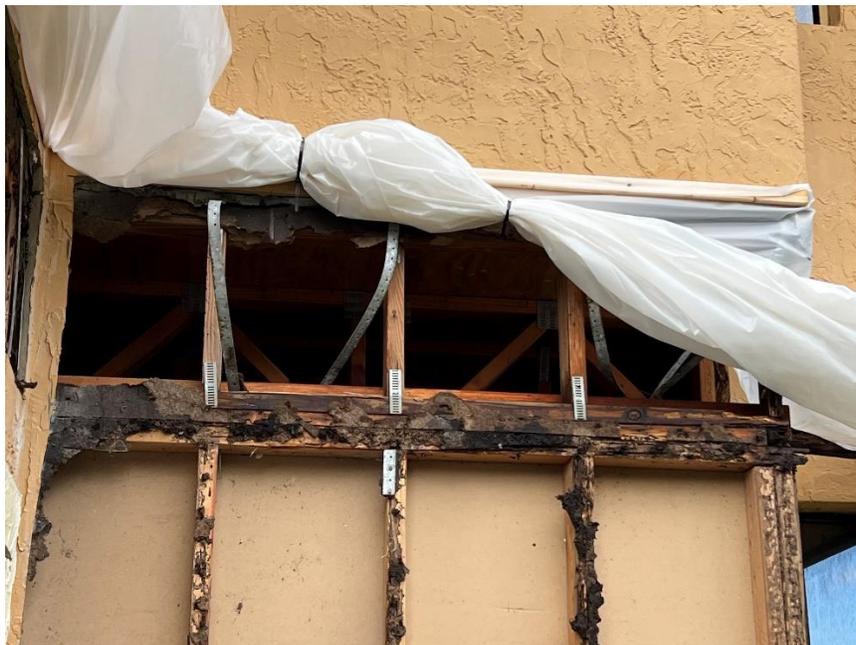
Photo #5 – The Floor Joist Most Directly Adjacent to the Removed Wall Panel Shows No Signs of Damage

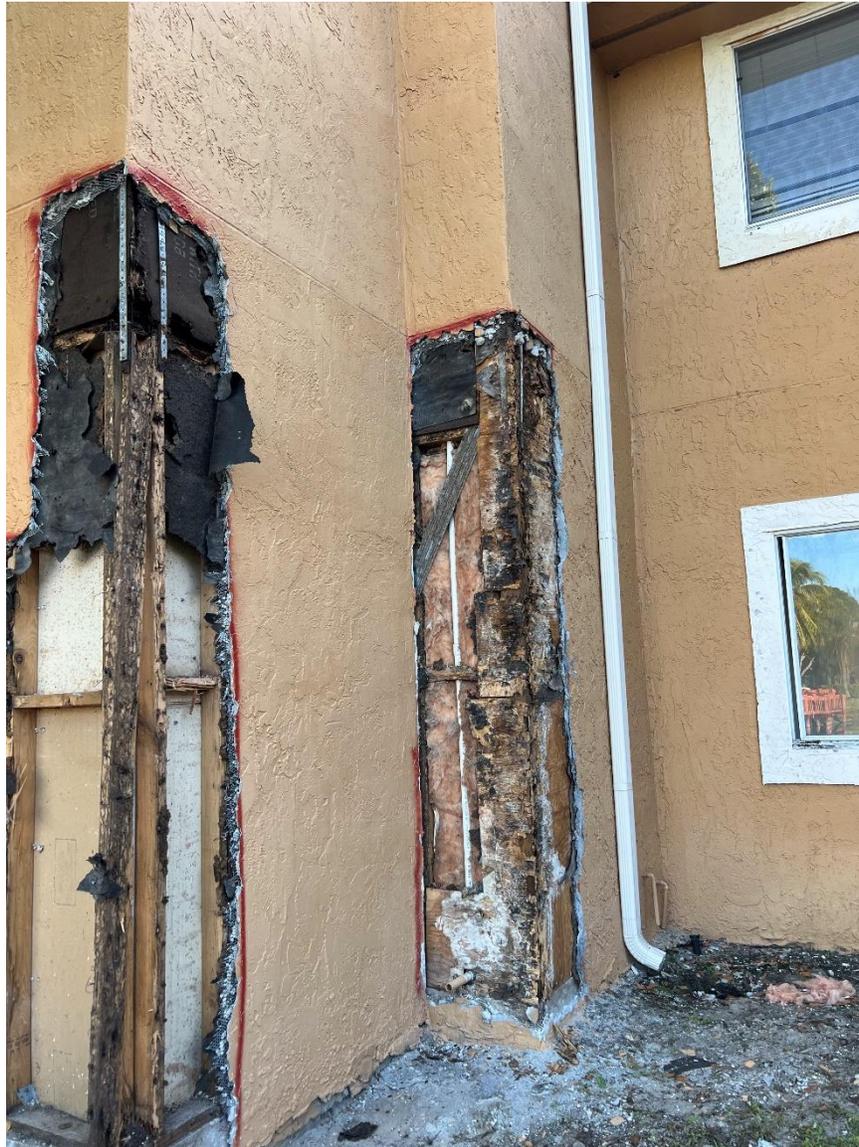
Photo #6 – Water Damage Is Evident, Having Affected the Sheathing at Both Corners
