November 28th, 2023

Re: Heron Pond Condominium
Structural Conditions – Building #2
Updated Findings

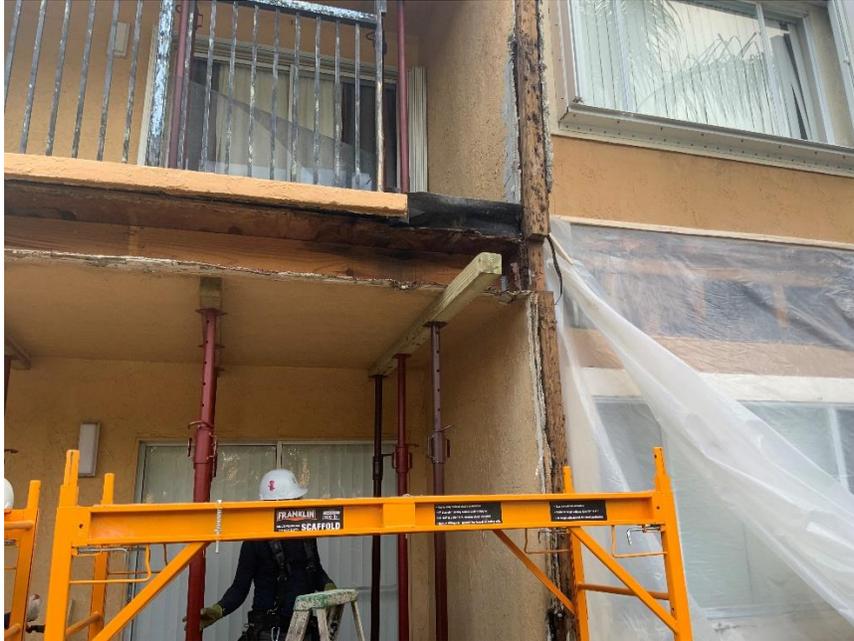
- Even the balcony damage appears to lessen as the affected structural members get further away from the outside balcony edges.
- A number of the building corners have sustained significant structural damage.

Photo #1 – Removed Severely Damaged Exterior Balcony Beam/
Revealing Adjacent Joist with Only Limited Damage

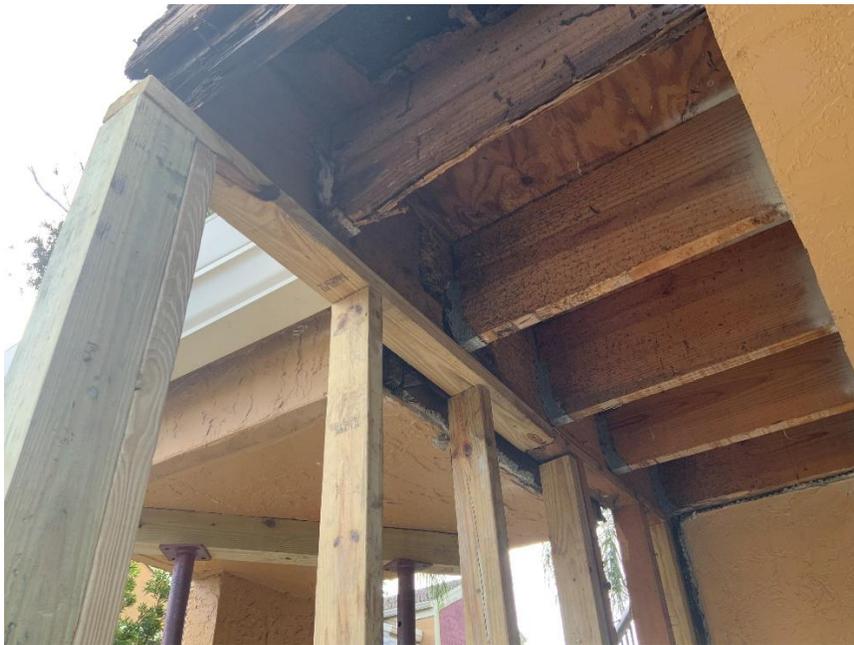
Photo #2 – Progression of Joist Damage/Each Joist, Moving in from
The Edge, Shows Less and Less Damage

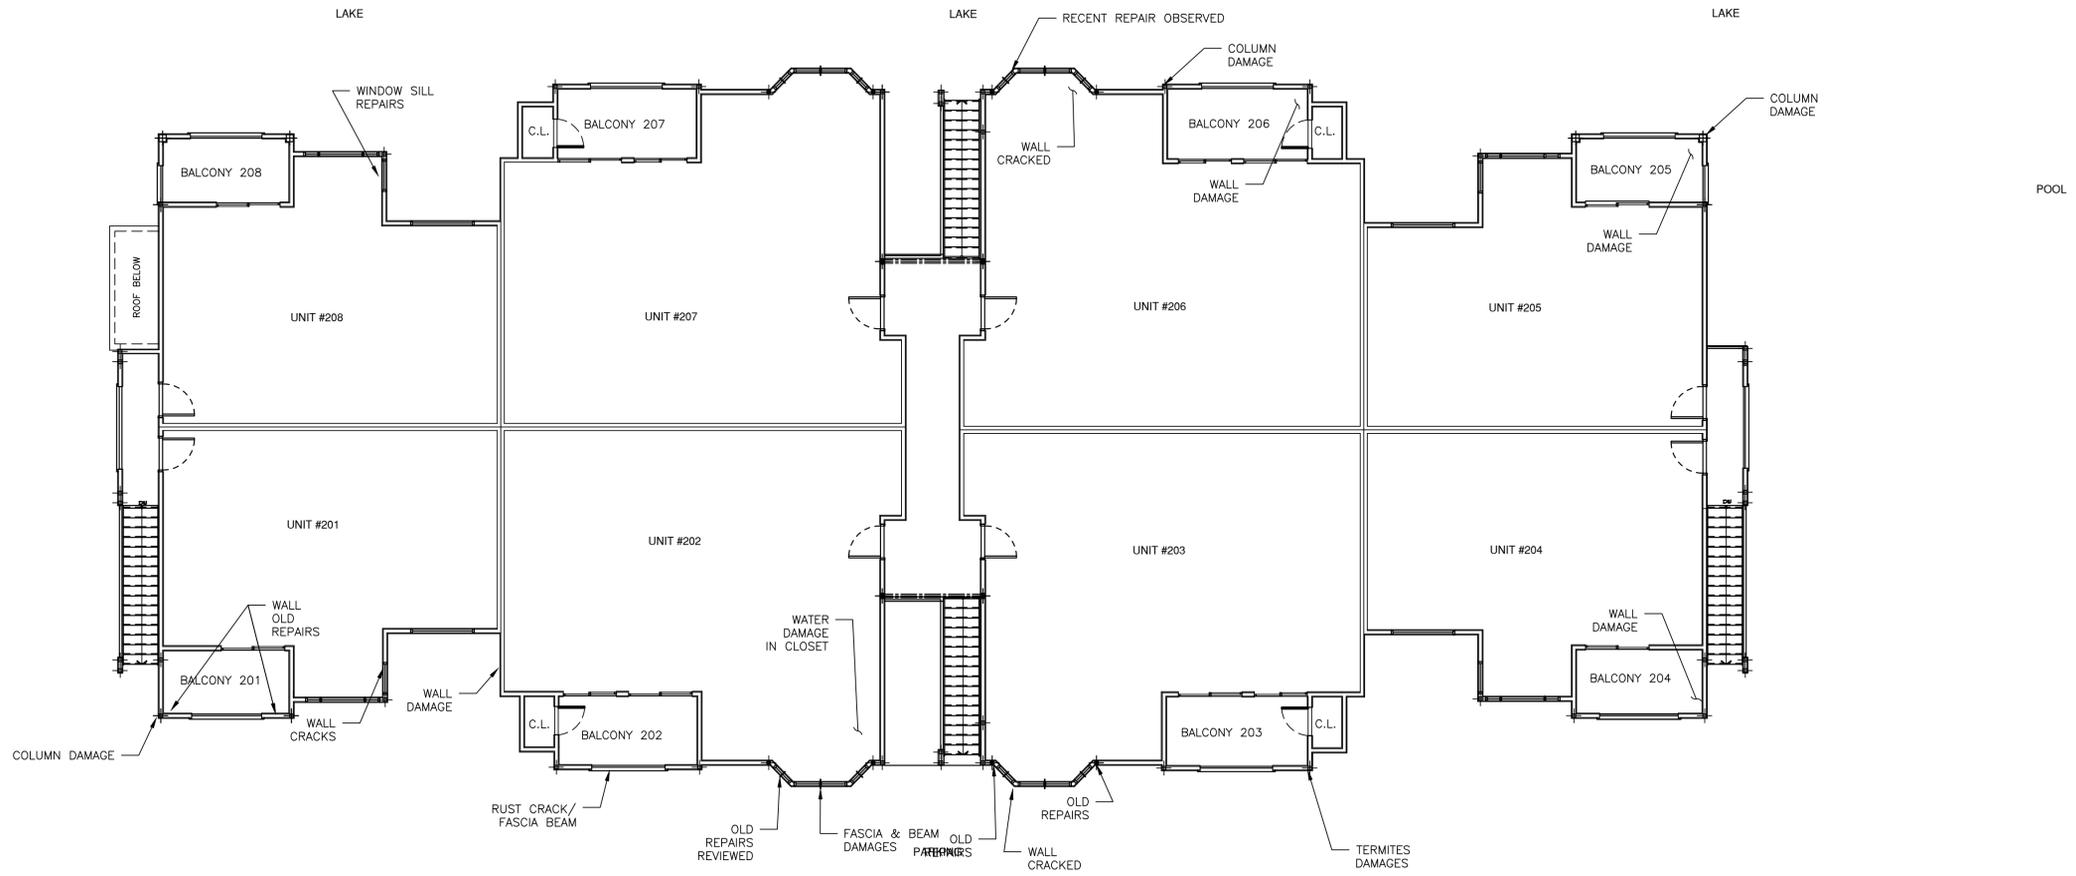
**SECOND FLOOR
BLDG. #2**

- There are signs of water damage in the closet of Unit #202.
- There are at least 54 different locations around the building where damage has been visually detected, involving at least 14 out of the 16 units.
- Additionally, signs of previous repairs have been noted at 25 other locations around the building.
- There are signs of damage visible on all eight (8) balcony stacks.
- There are signs of damage to sections of exterior walls that appear to carry significant second floor and roof loads.
- There are at least five (5) locations where damage has been observed in sections of the structure that clearly appear to have been recently repaired; in these locations fresh signs of damage are telegraphing through the finishes.
