November 28th, 2023

Re: Heron Pond Condominium
Structural Conditions – Building #4
Updated Findings

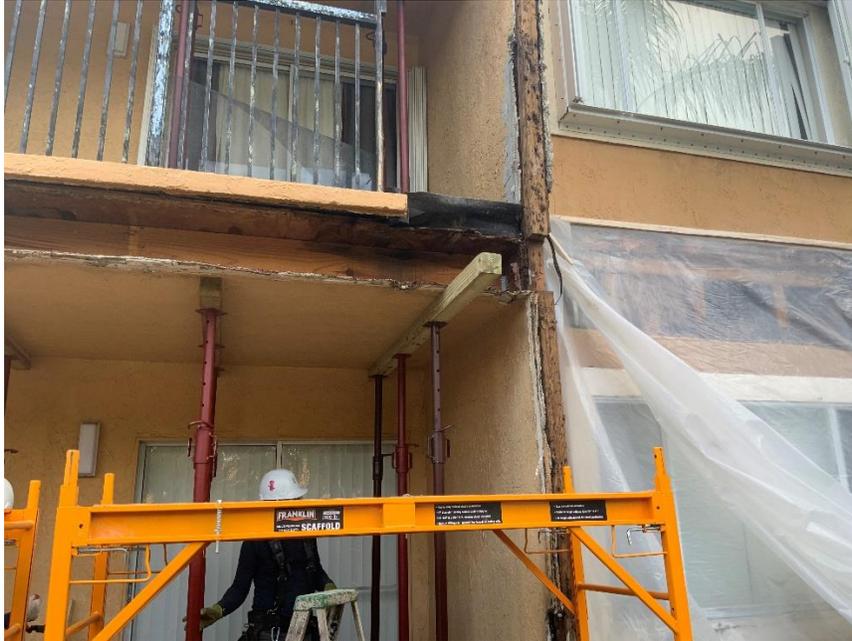
Photo #1 – Removed Severely Damaged Exterior Balcony Beam/
Revealing Adjacent Joist with Only Limited Damage

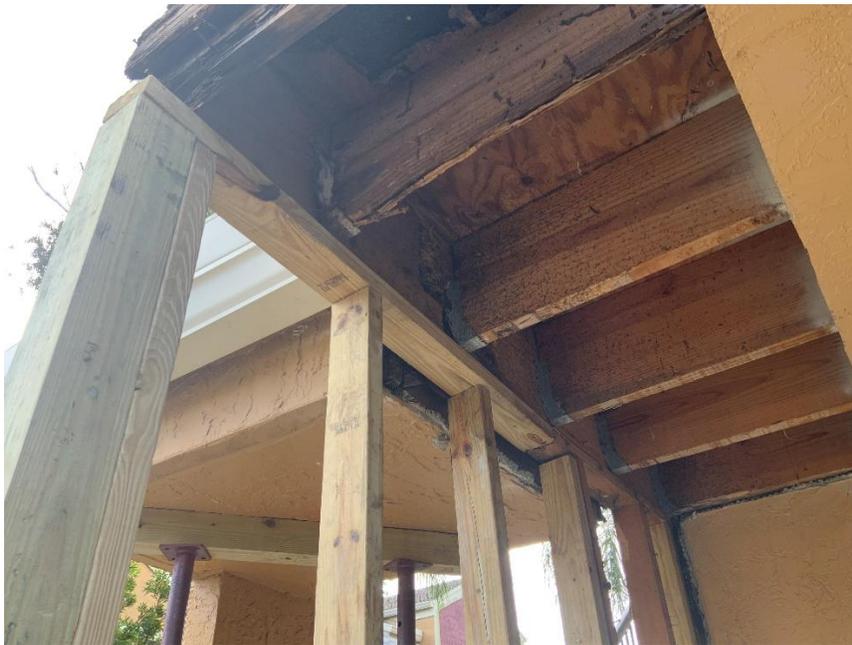
- Even the balcony damage appears to lessen as the affected structural members get further away from the outside balcony edges.
- A number of the building corners have sustained significant structural damage.

Photo #2 – Progression of Joist Damage/Each Joist, Moving in from
The Edge, Shows Less and Less Damage
