November 28<sup>th</sup>, 2023

Re: Heron Pond Condominium  
Structural Conditions – Building #8  
Updated Findings

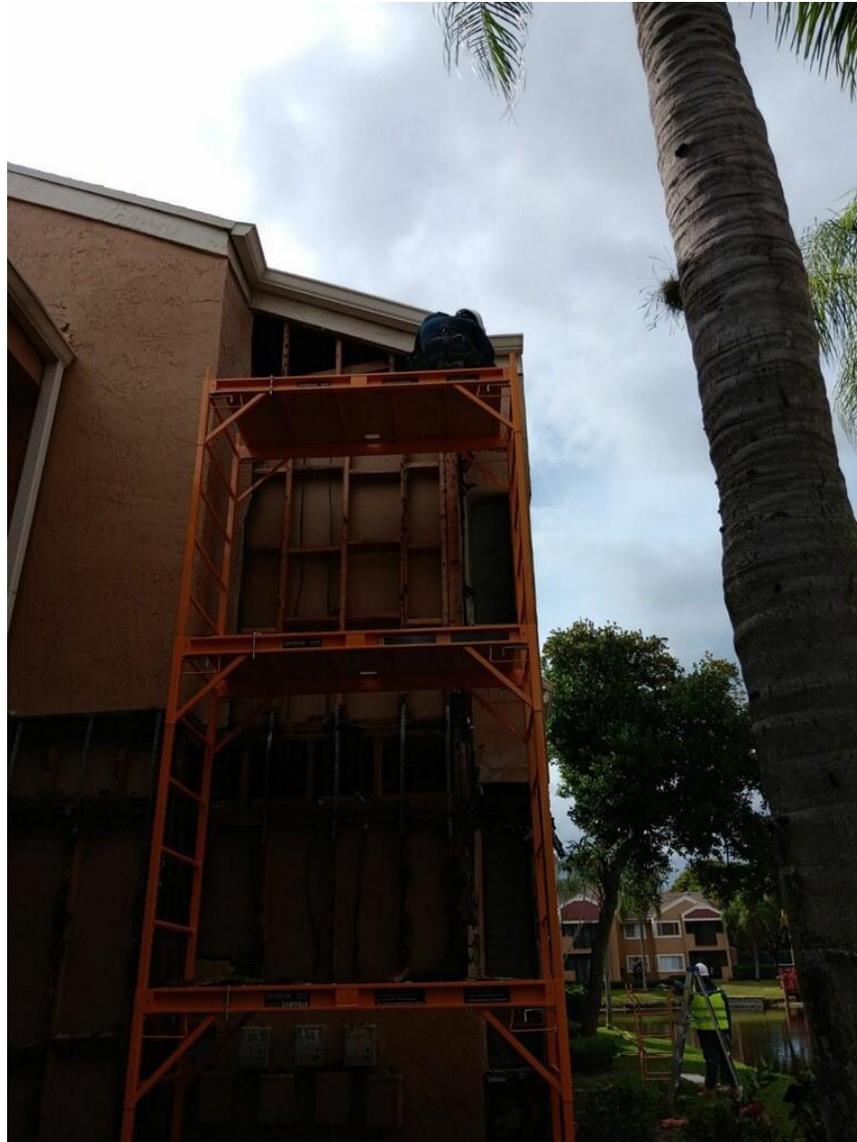
- To date, none of the second-floor trusses exposed by stucco and sheathing removal show section loss or compromise.
- The sections of the second-floor wall that have been exposed, even when directly adjacent to first floor wall damage, have been observed to be intact, with no appreciable damage witnessed.

Photo #7 – Sheathing Stripped from Both Levels of Wall/Showing That the Extensive Damage to the First Level Wall Does Not Translate to the Second Floor Wall Structure
