November 28th, 2023

Re: Heron Pond Condominium
Structural Conditions – Building #9
Updated Findings

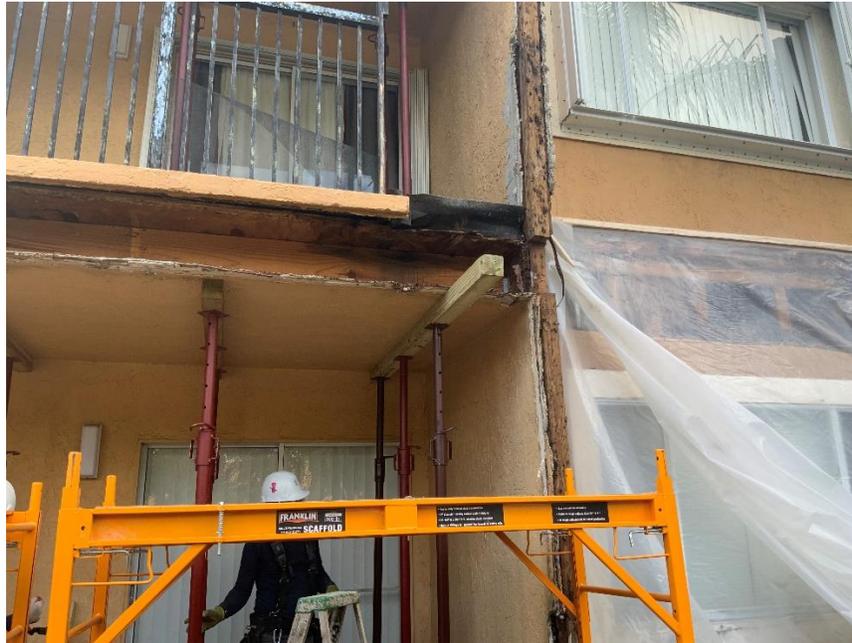
- The balconies, the portions of the building structures permanently and fully exposed to the weather and elements, have sustained the worst of the wood damage.

Photo #1 – Removed Severely Damaged Exterior Balcony Beam/
Revealing Adjacent Joist with Only Limited Damage

- All second-floor balcony and bay window structures should be shored and then rebuilt as required.
- The center stair should be shored until such time as it can be repaired.

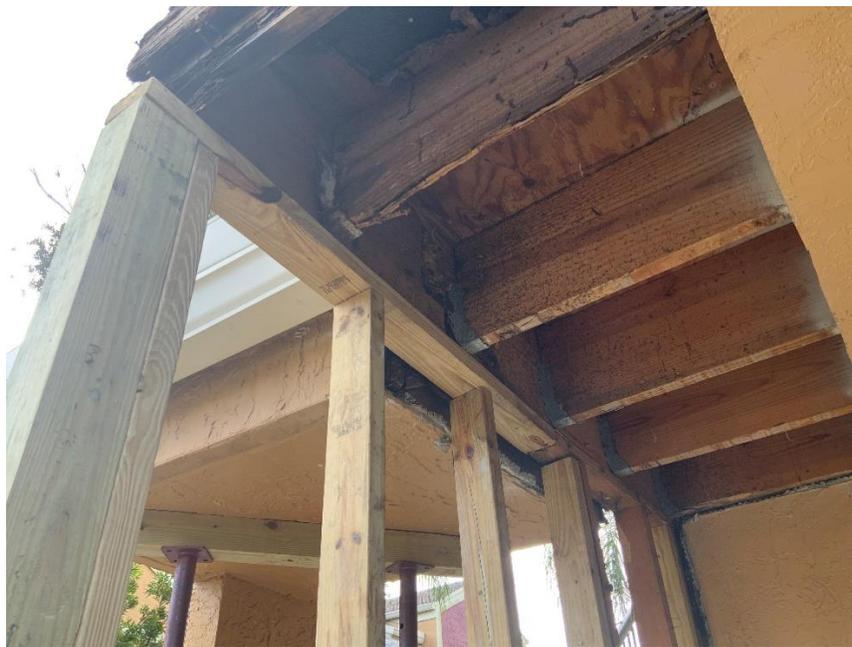
- Even the balcony damage appears to lessen as the affected structural members get further away from the outside balcony edges.
- A number of the building corners have sustained significant structural damage.

Photo #2 – Progression of Joist Damage/Each Joist, Moving in from
The Edge, Shows Less and Less Damage

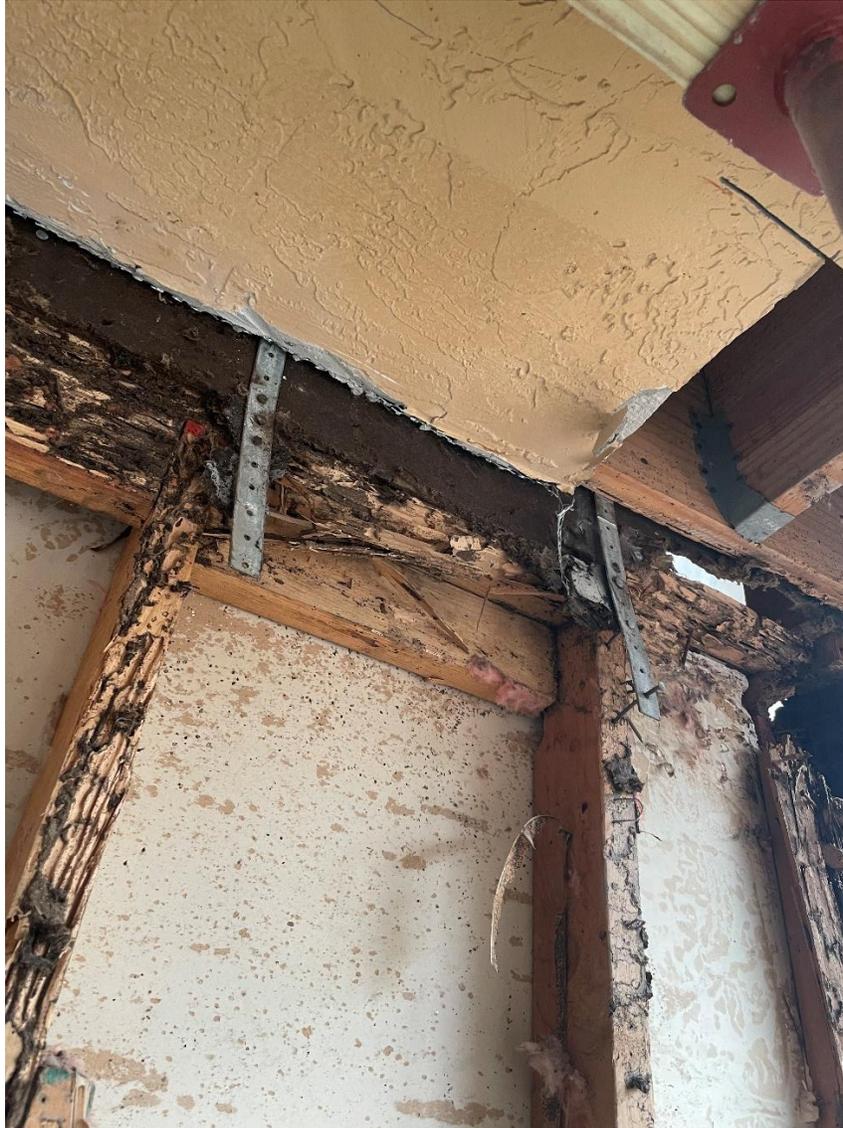
- The termite damage to the exterior walls appears to have originated with the paneling used as exterior sheathing. Termite “tunneling” appeared to run in between the inside face of the paneling and the exterior faces of the wall 2x4 members.

Photo #3 – Damage to Vertical Wall 2x4, Showing Termite “Tunneling”
Damage with the Deterioration on the 2x4 Face Adjacent to
The Exterior Panel (Not Shown)
