November 28th, 2023

Re: Heron Pond Condominium
Structural Conditions – Building #12
Updated Findings

Henry S. Kreh, P.E.
Vice President
ACG Engineering Services, Inc.
FL PE No. 39539/FL SI No. 736

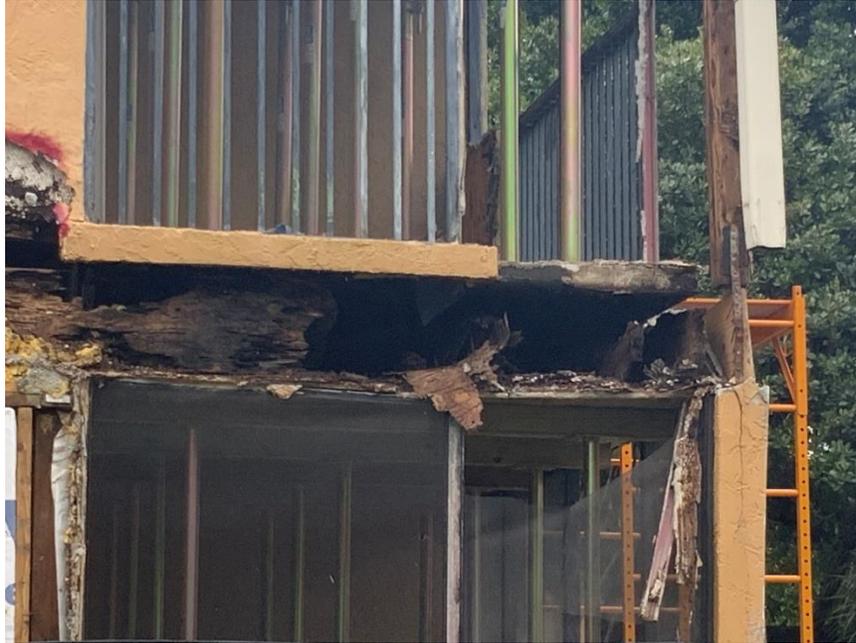
- The balconies, the portions of the building structures permanently and fully exposed to the weather and elements, have sustained the worst of the wood damage.

- All of the balcony stack structures, including joists, beams, and columns, have sustained significant structural damage.
- Some of the apparently compromised sections of exterior wall appear to carry considerable 2nd floor and/or roof loads, but do not appear to pose a safety concern at the present time. Prior to the removal of any structure during the repair process, the second floor and roof structures should be adequately shored.

Photo #4 – The Exterior Balcony Beam Has Been Completely Damaged And Removed/This Balcony Structure Damage is Severe

- All second-floor balcony and bay window structures should be shored and then rebuilt as required.
- The stair landing structures to Units #201/#208 and to Units #204/#205 should be shored until repaired.
