November 28th, 2023

Re: Heron Pond Condominium
Structural Conditions – Building #13
Updated Findings

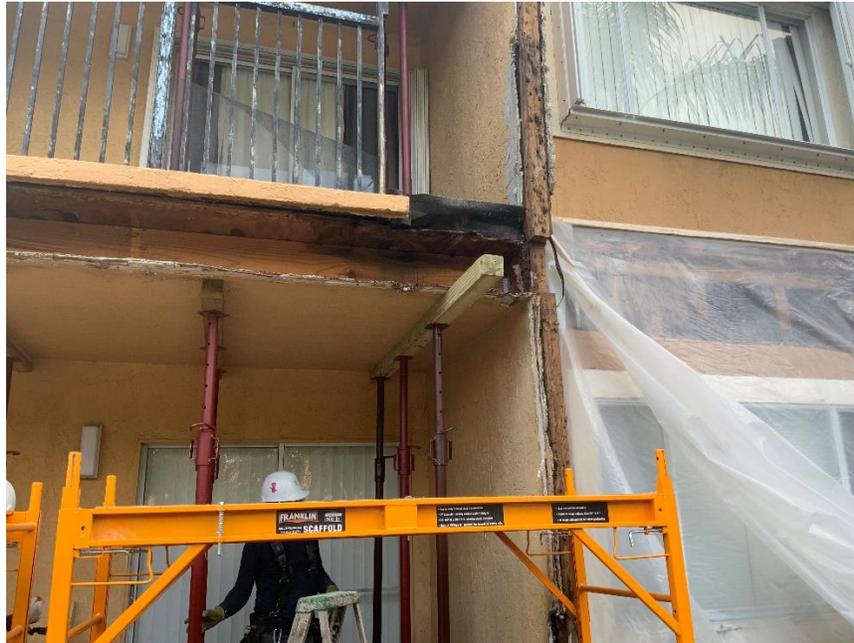
Photo #1 – Removed Severely Damaged Exterior Balcony Beam/
Revealing Adjacent Joist with Only Limited Damage

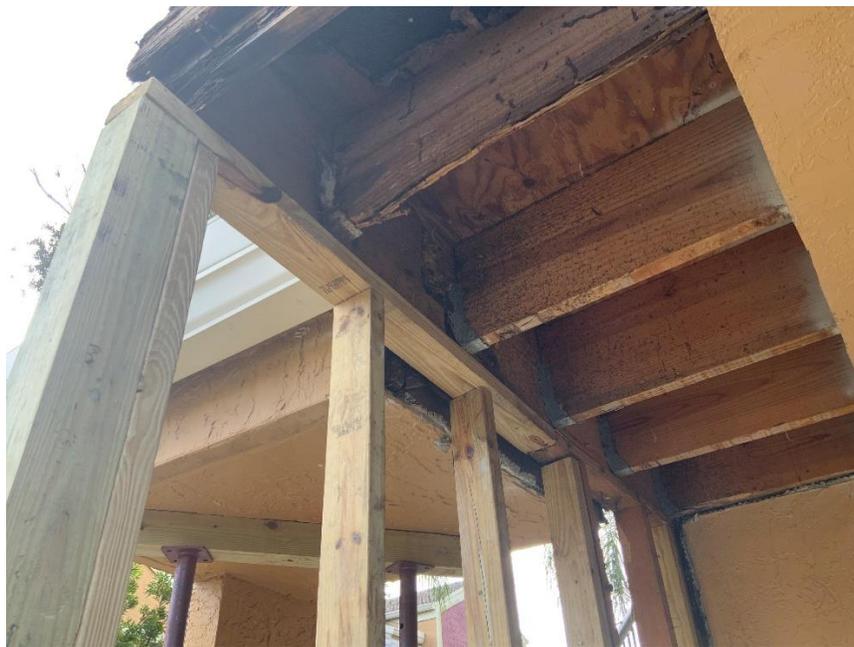
- Even the balcony damage appears to lessen as the affected structural members get further away from the outside balcony edges.
- A number of the building corners have sustained significant structural damage.

Photo #2 – Progression of Joist Damage/Each Joist, Moving in from
The Edge, Shows Less and Less Damage

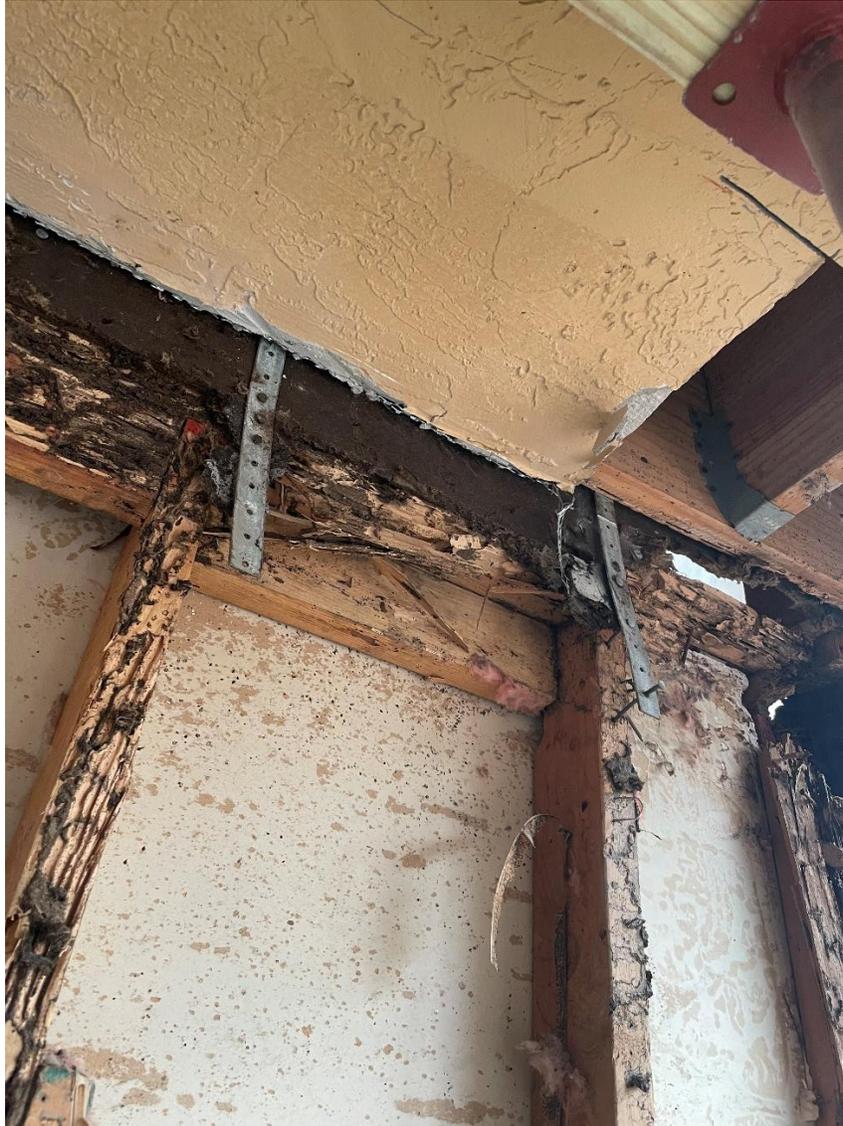
- The termite damage to the exterior walls appears to have originated with the paneling used as exterior sheathing. Termite “tunneling” appeared to run in between the inside face of the paneling and the exterior faces of the wall 2x4 members.

Photo #3 – Damage to Vertical Wall 2x4, Showing Termite “Tunneling”
Damage with the Deterioration on the 2x4 Face Adjacent to
The Exterior Panel (Not Shown)

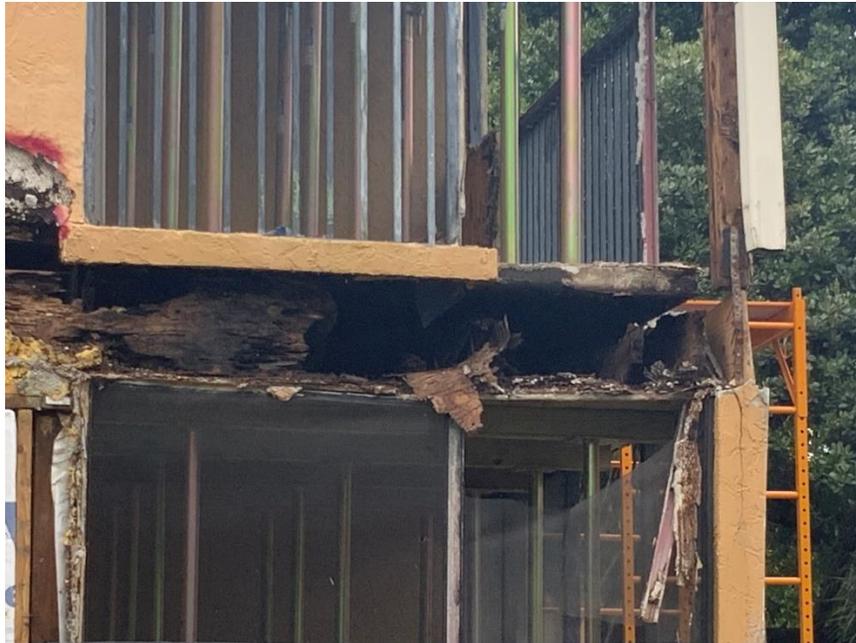
- The balconies, the portions of the building structures permanently and fully exposed to the weather and elements, have sustained the worst of the wood damage.

Photo #4 – The Exterior Balcony Beam Has Been Completely Damaged And Removed/This Balcony Structure Damage is Severe

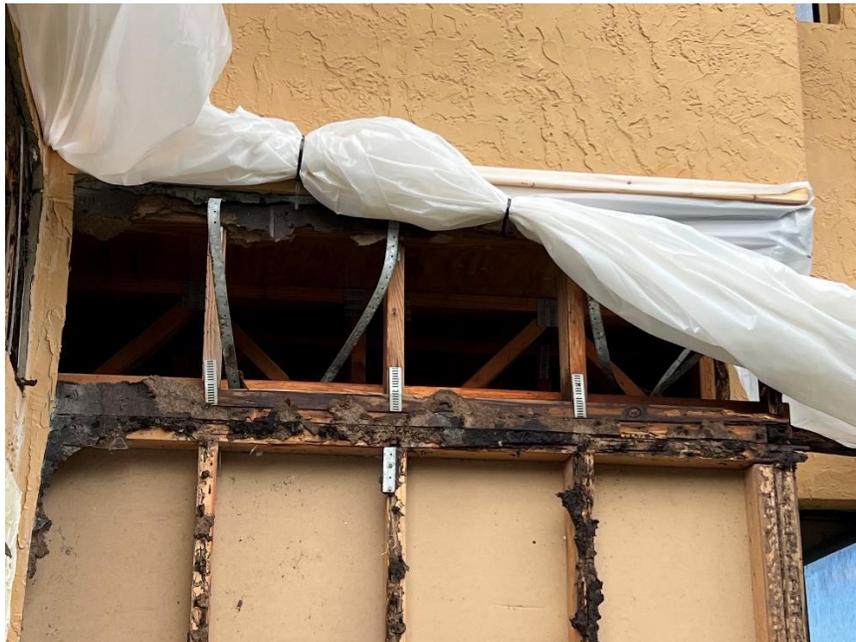
Photo #5 – The Floor Joist Most Directly Adjacent to the Removed Wall Panel Shows No Signs of Damage

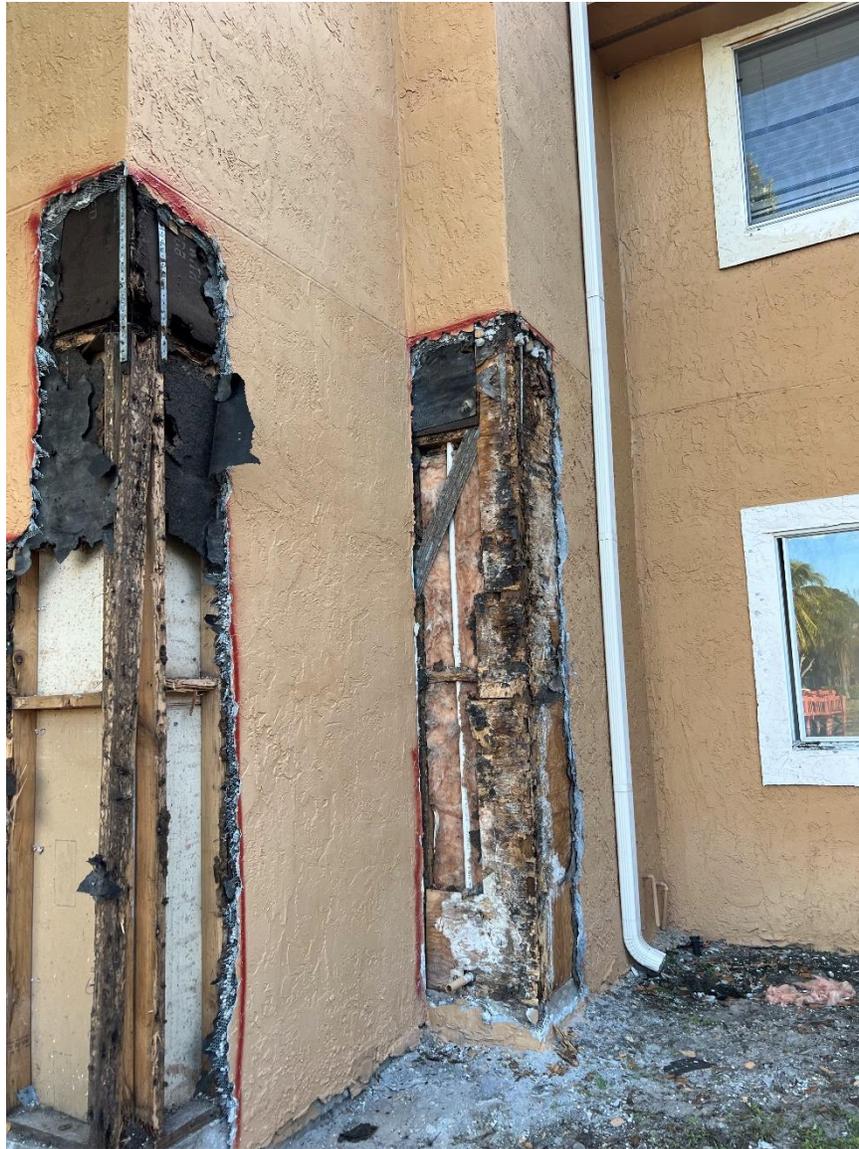
Photo #6 – Water Damage Is Evident, Having Affected the Sheathing at Both Corners

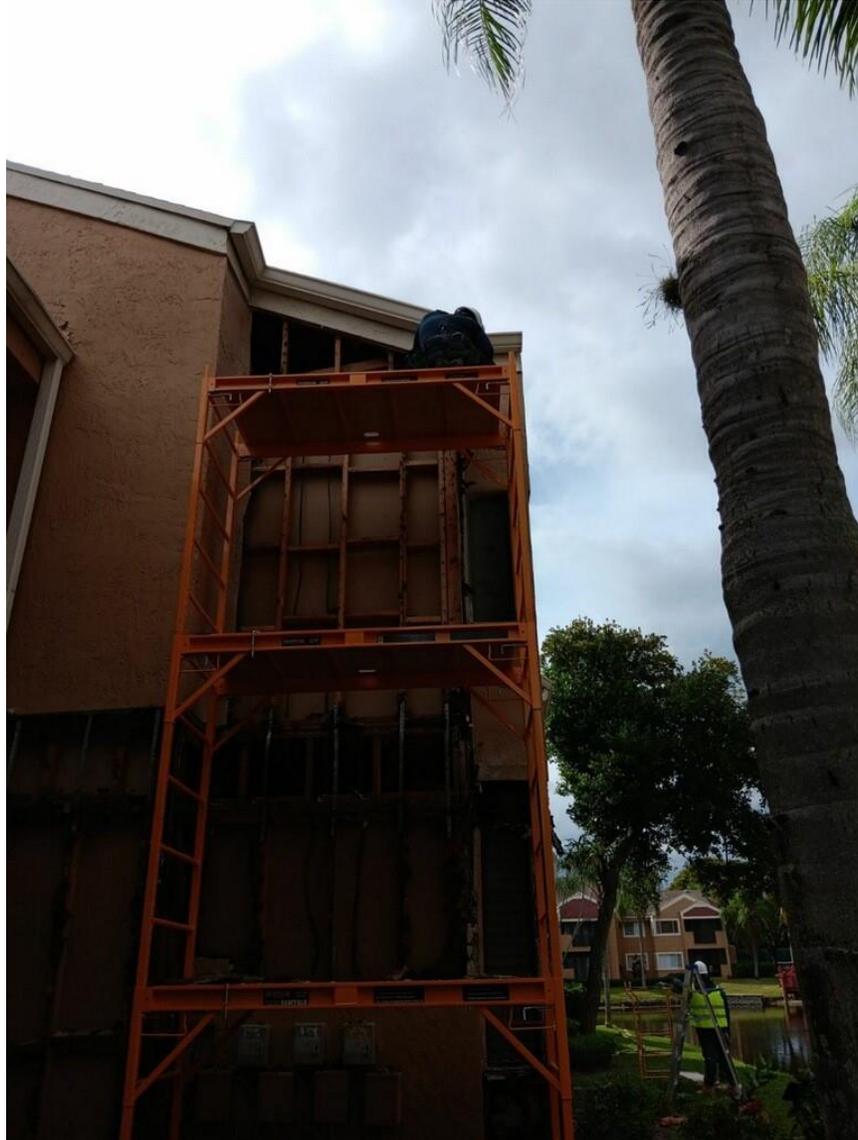
- To date, none of the second-floor trusses exposed by stucco and sheathing removal show section loss or compromise.
- The sections of the second-floor wall that have been exposed, even when directly adjacent to first floor wall damage, have been observed to be intact, with no appreciable damage witnessed.

Photo #7 – Sheathing Stripped from Both Levels of Wall/Showing That the Extensive Damage to the First Level Wall Does Not Translate to the Second Floor Wall Structure
