November 28th, 2023

Re: Heron Pond Condominium
Structural Conditions – Building #14
Updated Findings

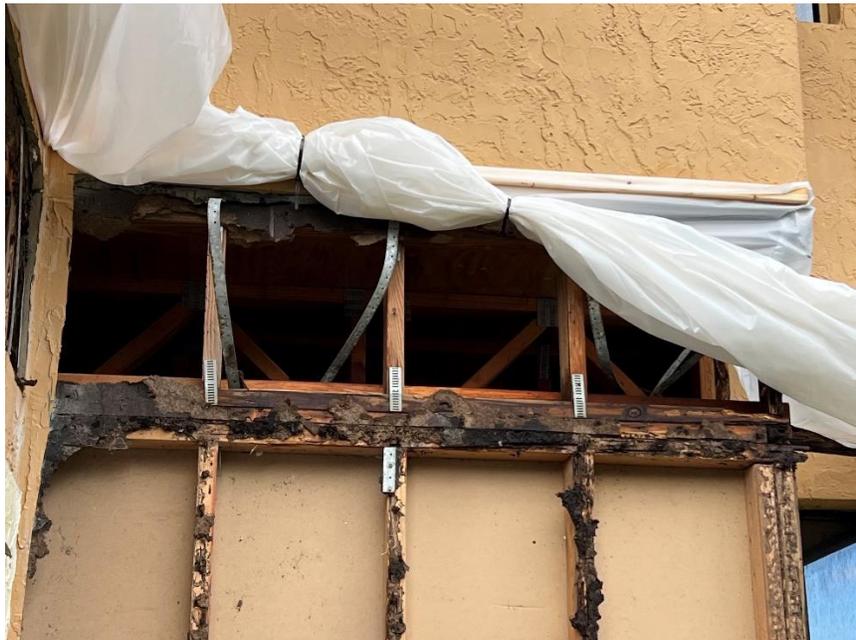
Photo #5 – The Floor Joist Most Directly Adjacent to the Removed Wall Panel Shows No Signs of Damage

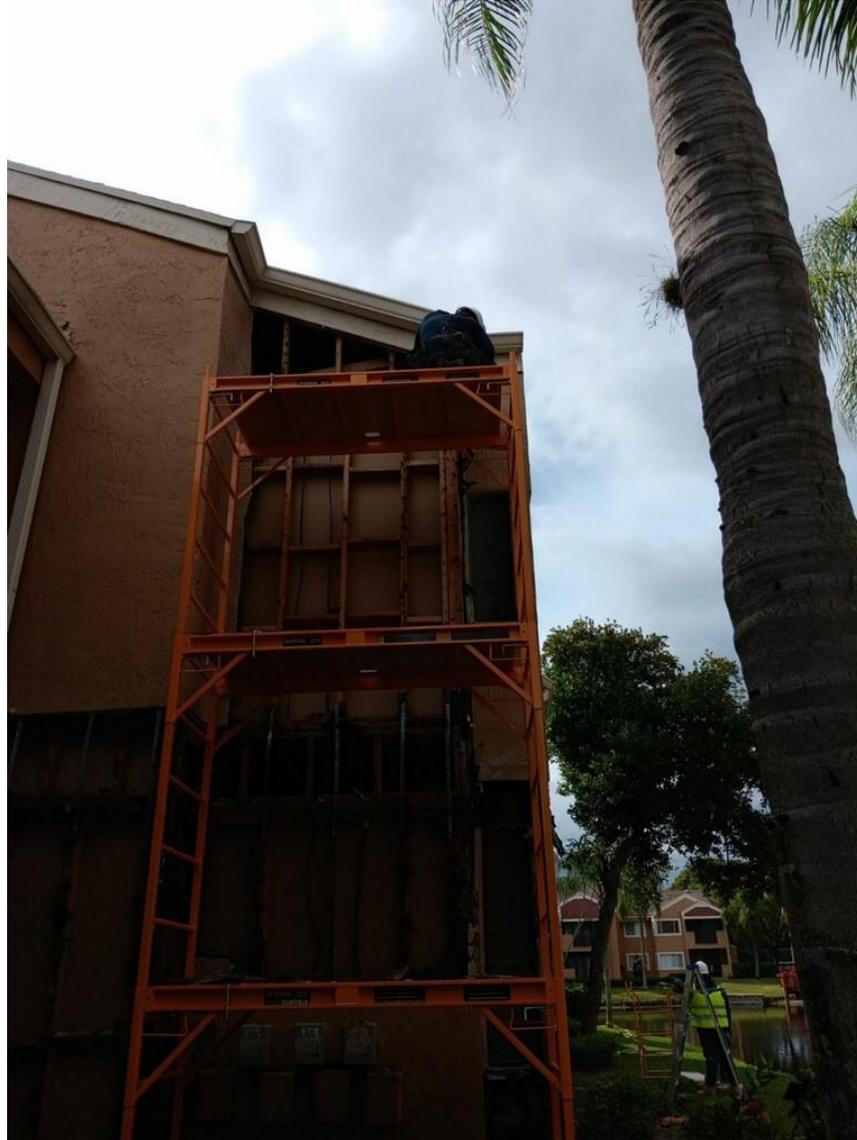
- To date, none of the second-floor trusses exposed by stucco and sheathing removal show section loss or compromise.
- The sections of the second-floor wall that have been exposed, even when directly adjacent to first floor wall damage, have been observed to be intact, with no appreciable damage witnessed.

Photo #7 – Sheathing Stripped from Both Levels of Wall/Showing That the Extensive Damage to the First Level Wall Does Not Translate to the Second Floor Wall Structure
