November 28th, 2023

Re: Heron Pond Condominium
Structural Conditions – Building #15
Updated Findings

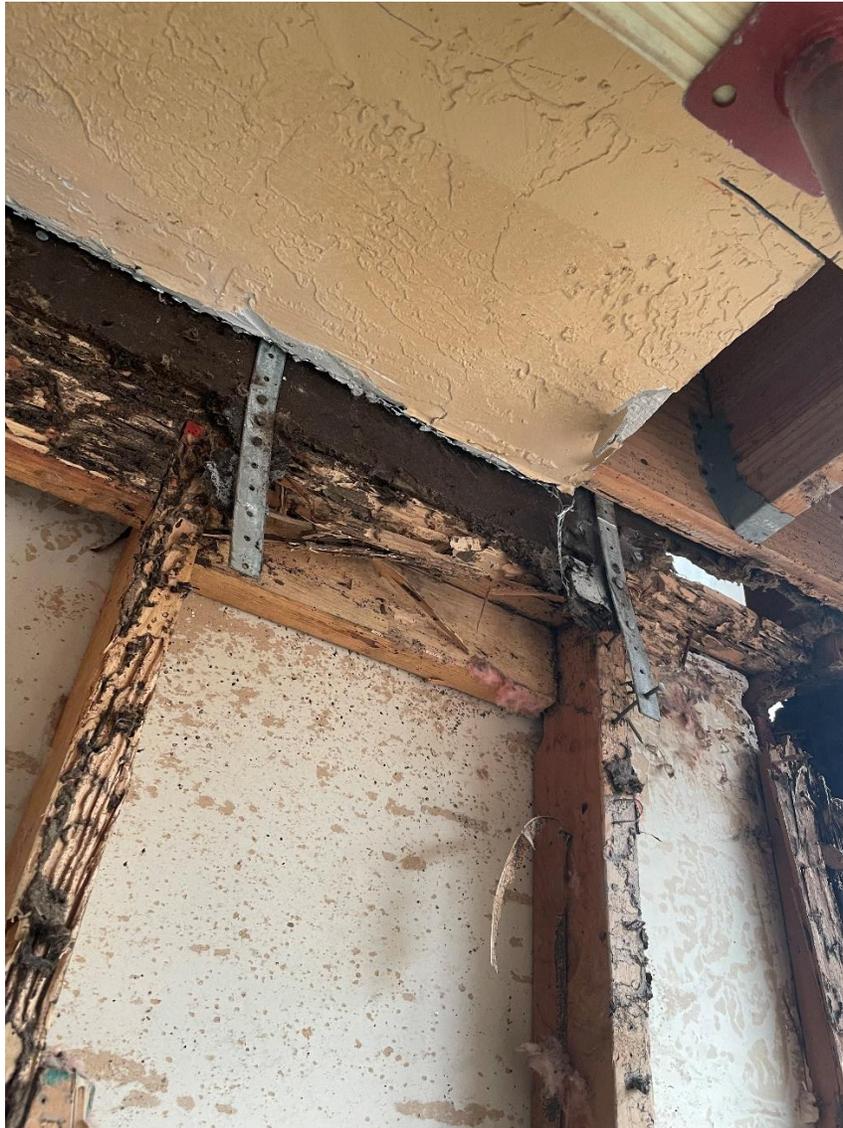
- The termite damage to the exterior walls appears to have originated with the paneling used as exterior sheathing. Termite “tunneling” appeared to run in between the inside face of the paneling and the exterior faces of the wall 2x4 members.

Photo #3 – Damage to Vertical Wall 2x4, Showing Termite “Tunneling”
Damage with the Deterioration on the 2x4 Face Adjacent to
The Exterior Panel (Not Shown)
