Re: City of Pembroke Pines (the "City") / Heron Pond Condominium Association, Inc.
(the "Association") / Building Code Issues / Property Located at 8400 SW 1st Street,
Pembroke Pines, FL 33025 (the "Property")

Pembroke Pines Building Department
Steve Pizzillo, C.B.O.

Reason: Heron Pond Unsafe Conditions

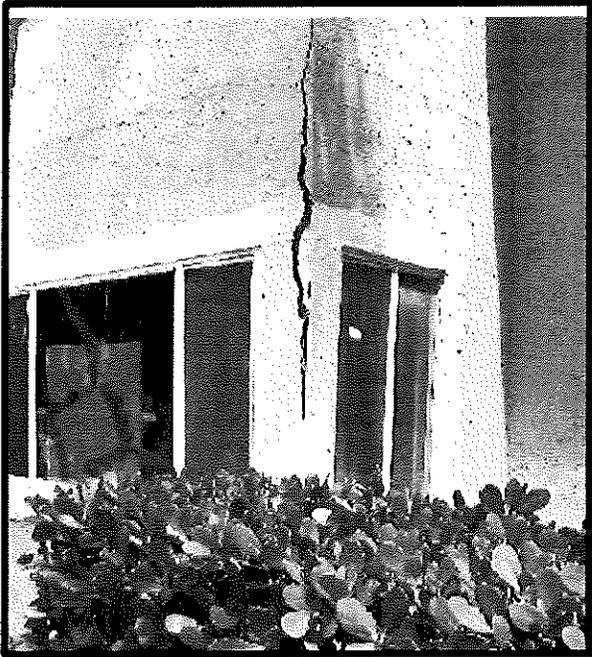
Building 10
Corner roof support Column 2021

The following pictures show the progression of the damage on an element of the building not covered in the Castro Report.

As can be seen in these pictures taken approximately 20 months apart which shows the advancement of the damage which is not being addressed in the Castro report.
